# Repetitive Loss Area Analysis

**Martin County, Florida**  
**CRS Community**  
**120161**

**September 29, 2026**

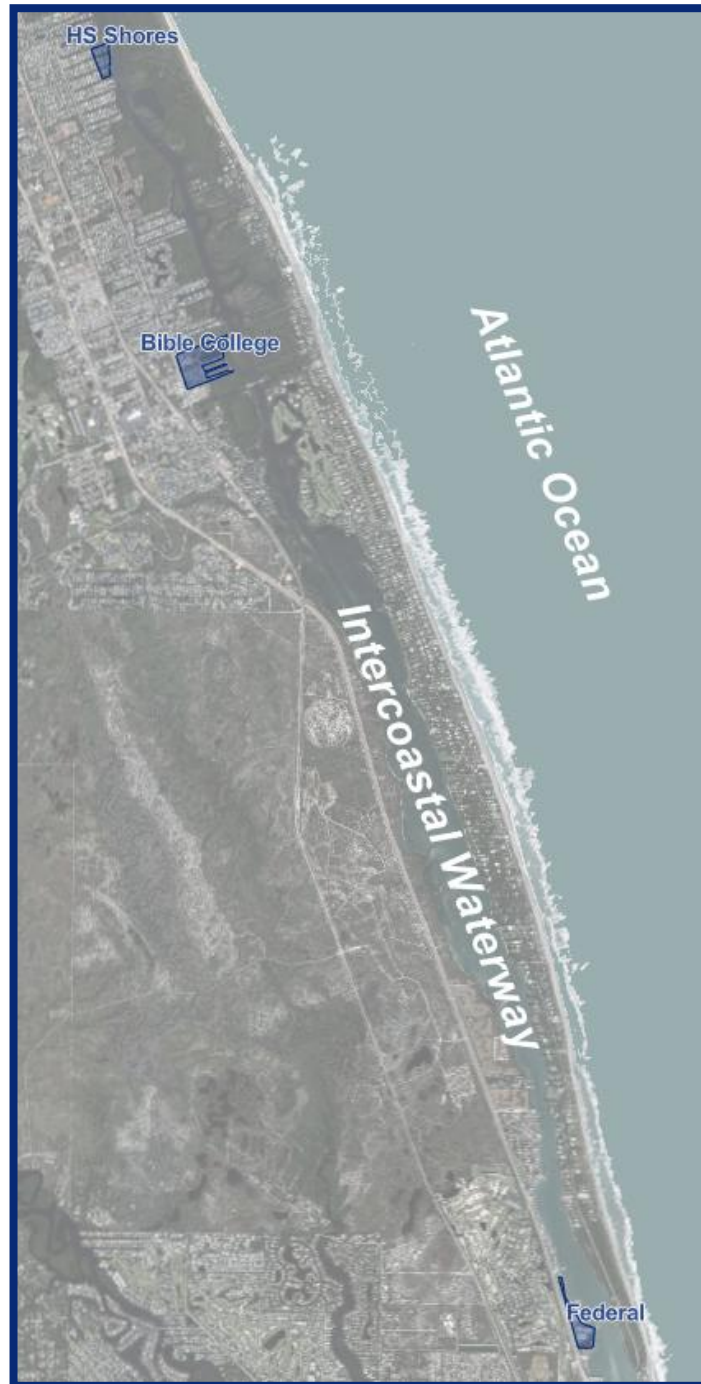
- HS Shores

The Bible College is a collection of institutional and residential structures that were built in the mid-20<sup>th</sup> century. Most of these structures were built on slabs, but this was not verified. Buildings in Federal are both residential and non-residential, but they are mostly built on slabs. HS Shores is a collection of streets with canal access to the Intercoastal Waterway. The homes are predominantly built on slabs, although some have recently been replaced with raised structures.

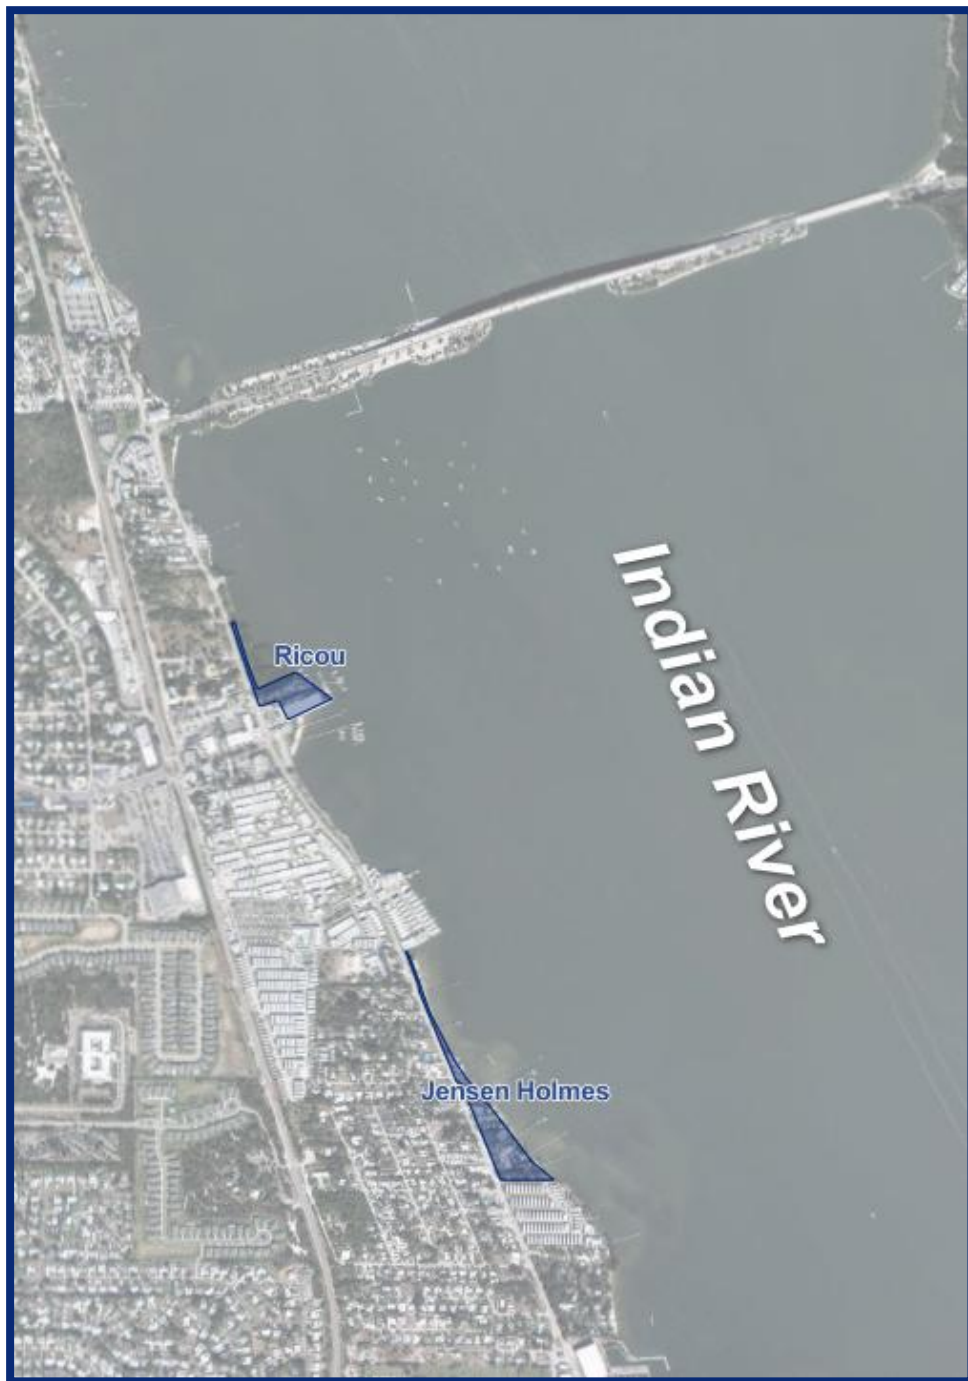
- Jensen Holmes
- Ricou

The buildings in Jensen Holmes are mostly single-family slab-on-grade with a small resort complex, and those in Ricou are non-residential. The buildings in Ricou are non-residential and are raised above ground.

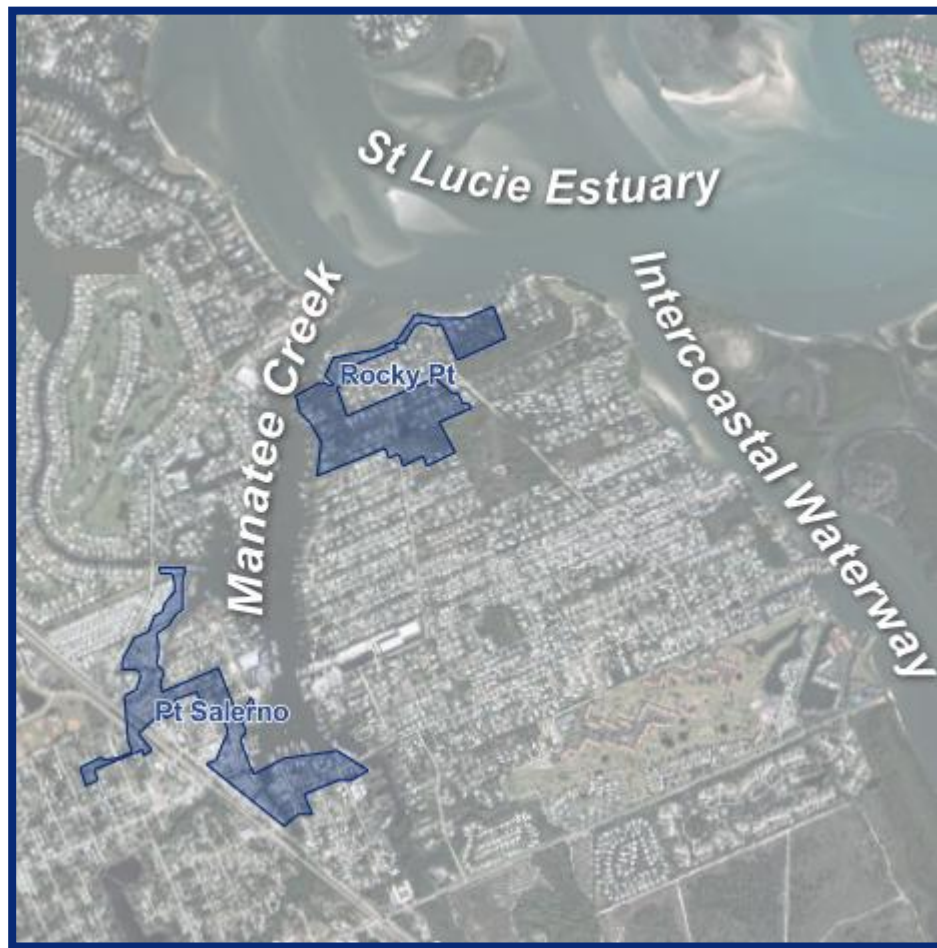
- Pt Salerno
- Rocky Pt

Pt Salerno consists of a mixture of residential and non-residential buildings that were mostly built on slabs in the 1960s and 1970s, however there has been recent development in the Port Salerno Community Redevelopment Area, where current flood protection standards apply. Rocky Pt is a residential community with most homes built on slabs in the latter part of the 1900s.

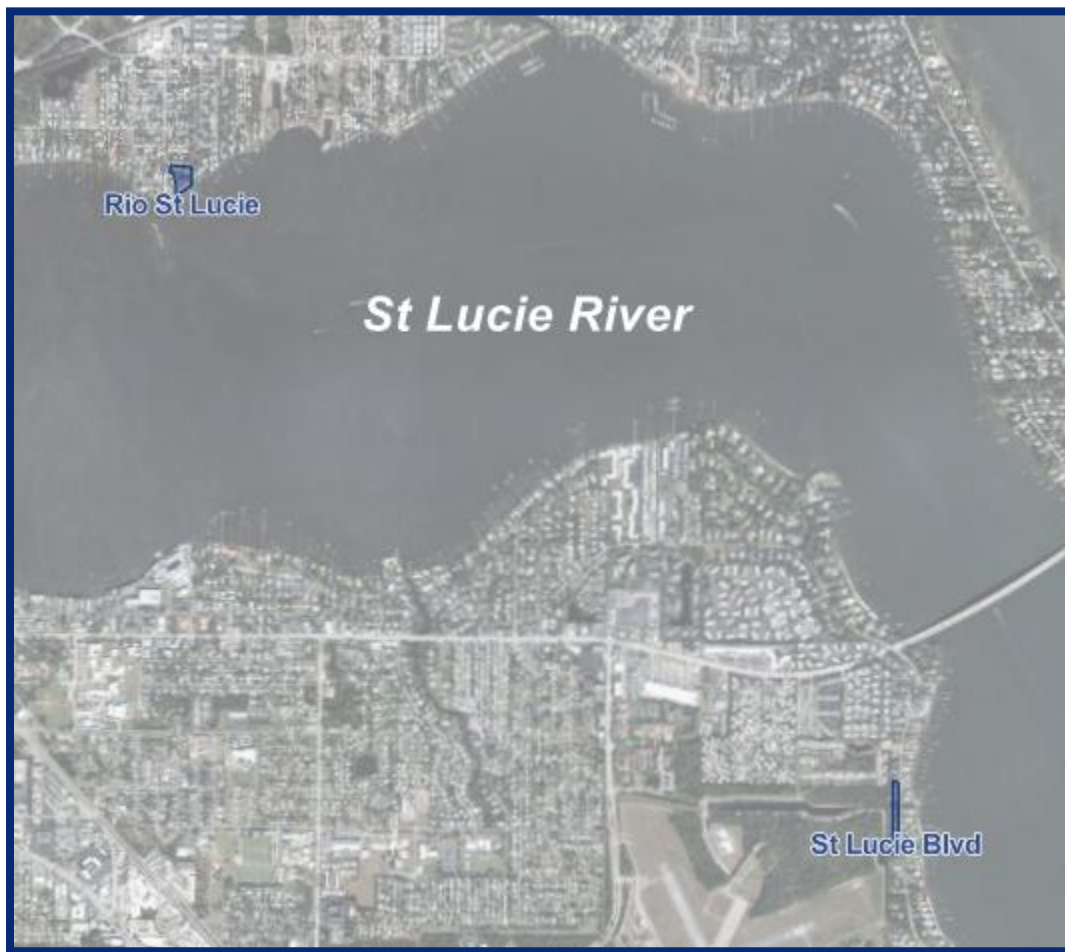
- Rio St Lucie
- St Lucie Blvd

The homes in Rio St Lucie and St Lucie Blvd are one and two story homes, built on slabs mostly in the 1970s.

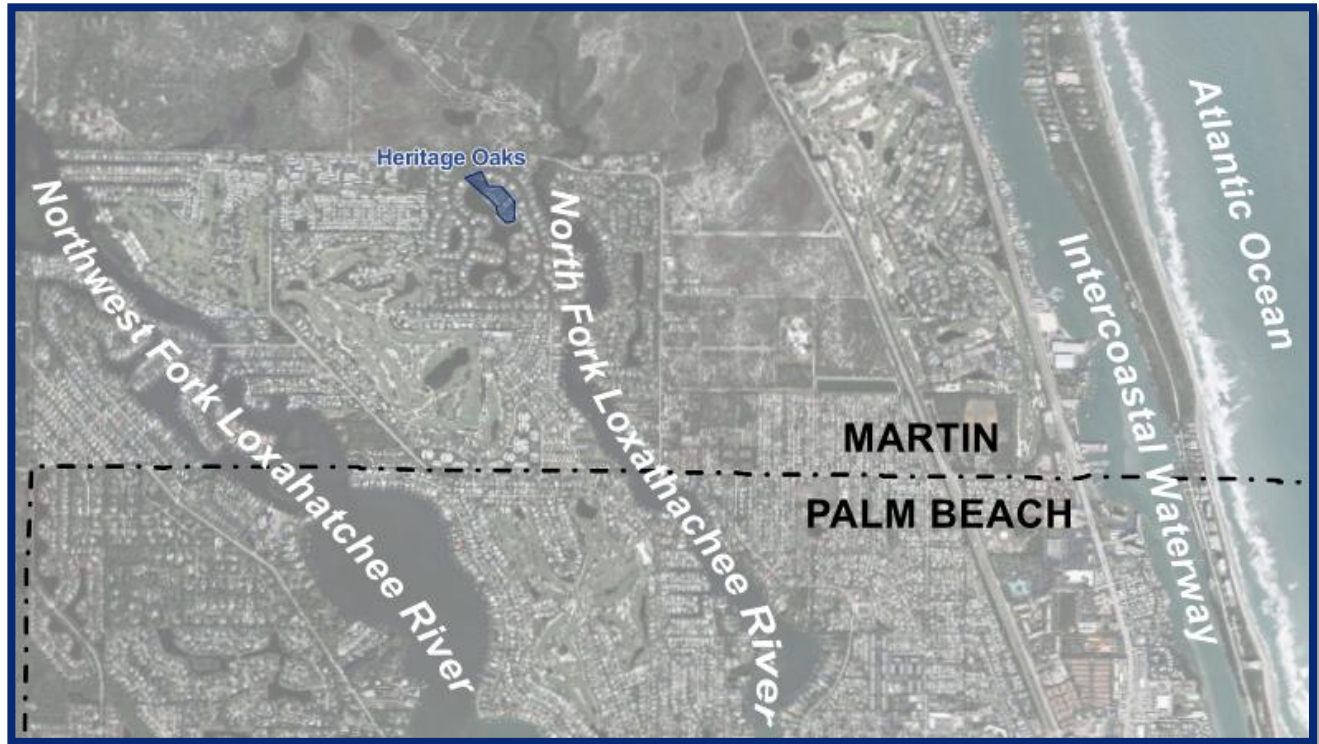
- Heritage Oaks

Heritage Oaks was developed in the mid-1990s with an approved stormwater management system that was designed to protect the finished floors from flooding. The homes in this neighborhood are built on slabs.
