# 2010 ANNUAL MONITORING REPORT

## MARTIN COUNTY ARTIFICIAL REEFS

MARTIN COUNTY ENGINEERING DEPARTMENT  
2401 SE MONTEREY ROAD  
STUART, FLORIDA 34996

20 SEPTEMBER 2011

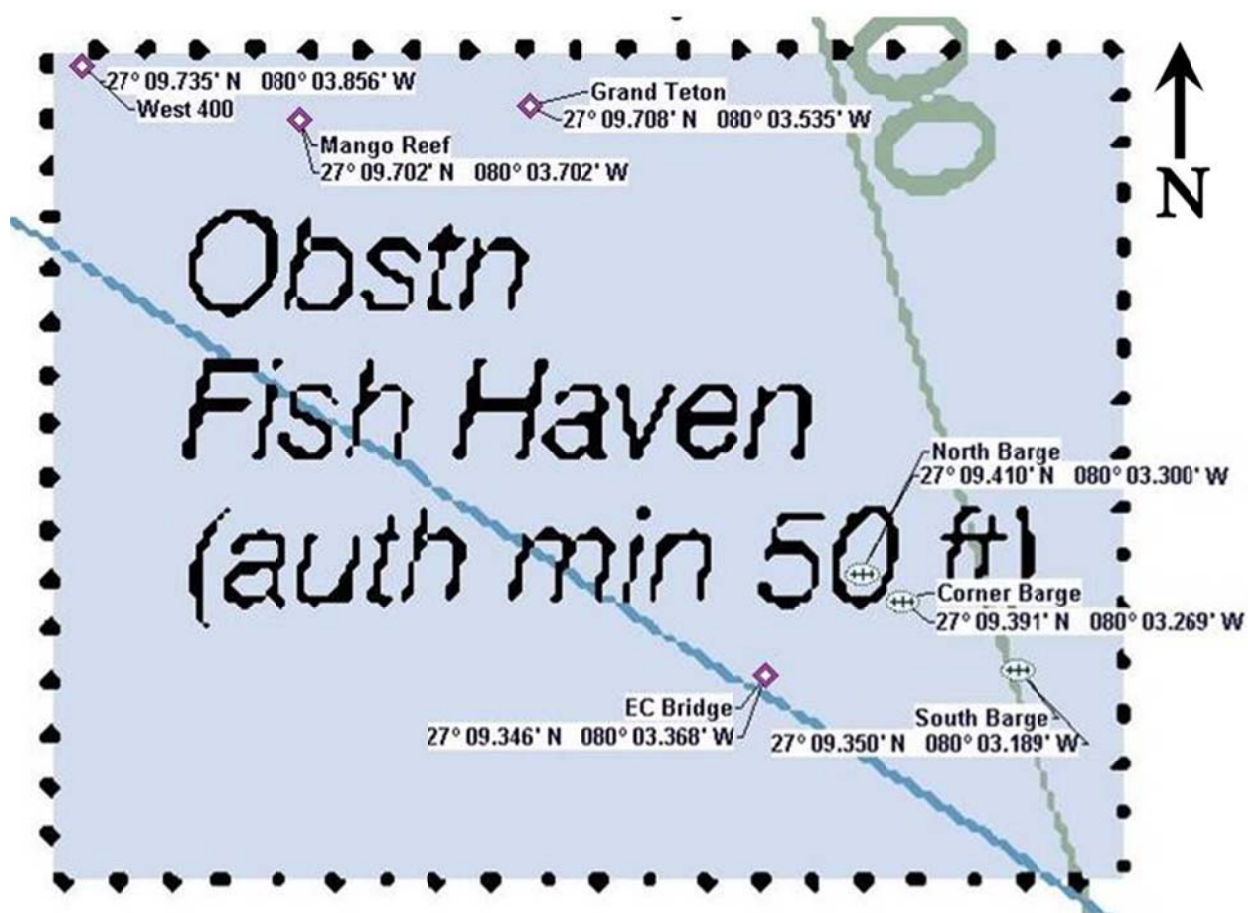
Figure 4. Chart view of the Ernst Artificial Reef site.

The Ernst Artificial Reef area (Figure 4) is located about 4 nautical miles due east of the St. Lucie Inlet sea buoy. There are seven known artificial reef sites within this area lying in 60 to 80 feet of water. The newest deployments (2007) in this area are the West 400, Mango, and Grand Teton artificial reefs, all located along the northern boundary of the permitted reef area. Each of these newer artificial reefs was constructed of recycled concrete materials from the Martin County landfill.

Prior deployments to this artificial reef area include the Evans Crary Bridge Reef, an expansive, high relief structure constructed from recycled bridge materials. This artificial reef was deployed in 2000. Other known reefs located within this site include the remnants of three barges, which were deployed in 1972 near the southeast corner of the permitted artificial reef area. All of the artificial reefs in the Ernst Artificial Reef area are very popular with fishermen and scuba divers.

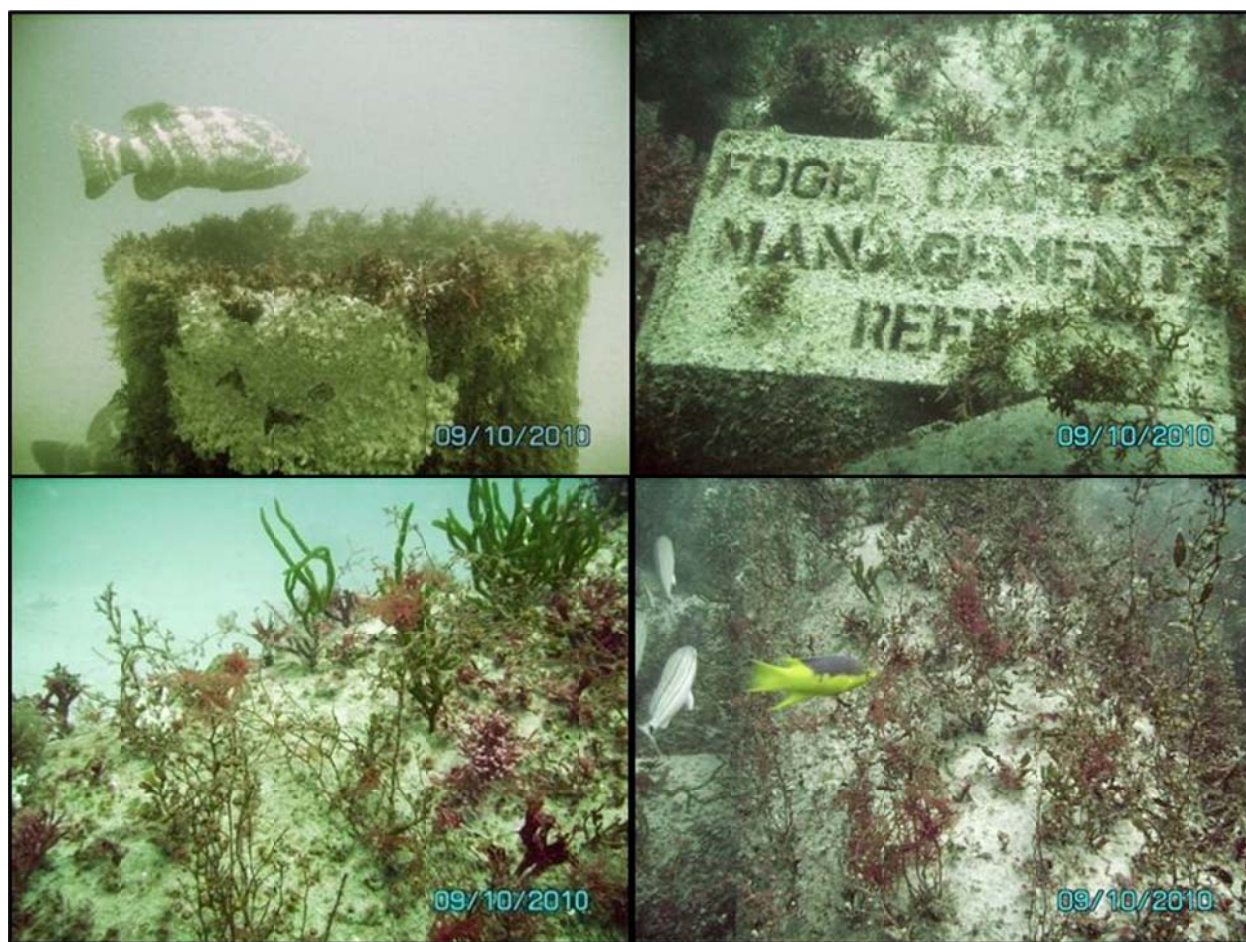
Figure 8. Fogel Capital Management Artificial Reef 2010 photographs.

The maximum depth at this artificial reef site is 71 feet with a maximum relief of about 11 feet. The footprint of the site is oval shaped with a southeast-to-northwest axis and occupies about 0.5 acres of seafloor. The deployment barge was securely moored at two points when the reef materials were dropped and the large concrete components settled in a single pile, although a few pieces settled to the bottom a short distance from the reef pile. Several large culvert sections provide cavernous recesses that are used extensively by large and small fish alike. Many culverts landed in a vertical position and have remained upright since their deployment. Some settling of the materials has occurred and minimal scouring has taken place. The photographs in Figure 8 are from the monitoring dive and show general conditions of the reef and some of the species observed during the dive.

Identification of species in the photographs shown above in clockwise order from the upper-left photograph are (1) goliath grouper, (2) Sergeant Major & Fogel Capital Management Reef sign, (3) spanish hogfish & tomtates, and (4) various marine plants and algae, no fish.

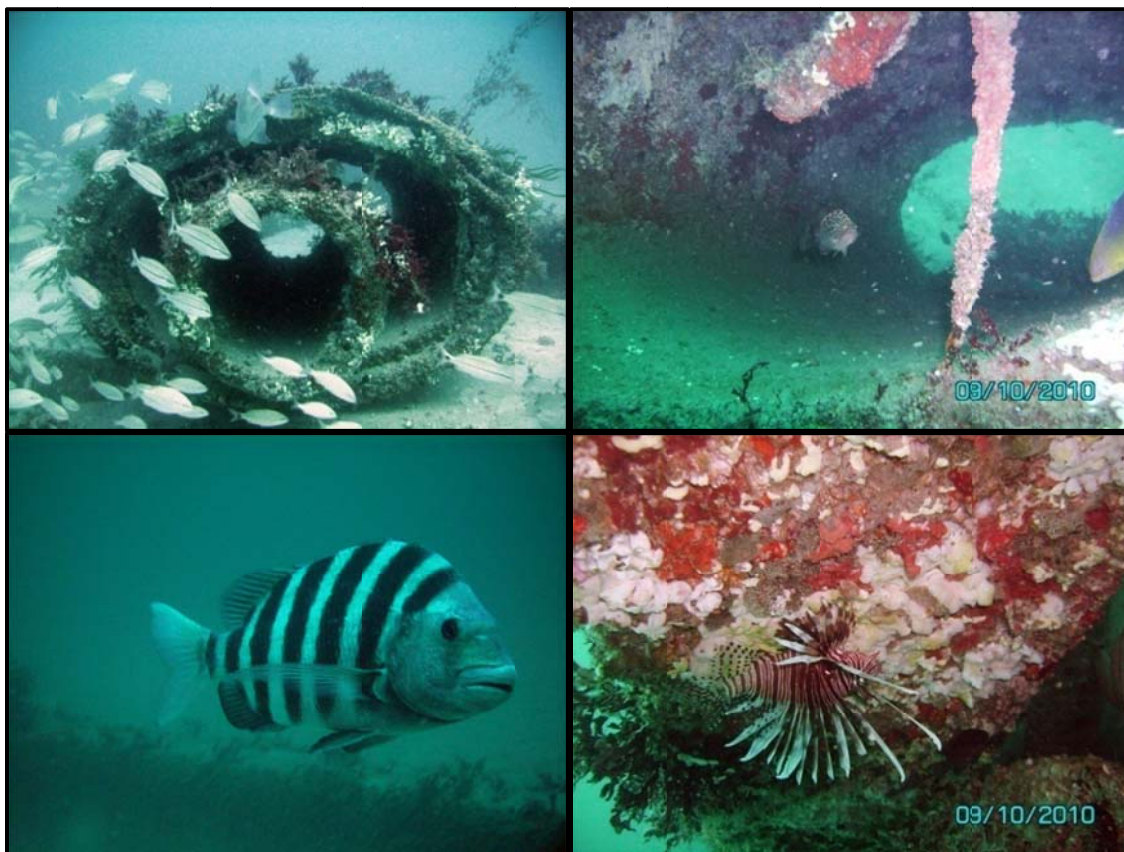
Figure 10. The Heap Artificial Reef 2010 photographs.

The maximum depth at this artificial reef site is about 64 feet with a maximum relief of about 4 feet. The footprint of the site is generally round with an irregular margin and occupies about 0.4 acres of seafloor. The deployment barge was securely moored at two points when the reef materials were deployed, this particular barge load had many smaller pieces than others and much scattering of the materials occurred resulting in a lower profile reef site. Many low profile concrete slabs were deployed here as well. The seafloor at this site is comprised of a shell/sand mixture and appears to have provided a marginally solid base for the heavy concrete and steel pieces. More scouring has occurred at this site, up to 3 feet, typically between 1 to 2 feet; therefore the overall profile is the lowest of the six South County artificial reef sites. The photographs in Figure 10 are from the monitoring dive and show general conditions of the reef and some of the species observed during the dive.

Identification of species in the photographs shown above in clockwise order from the upper-left photograph are (1) tomtates and ocean trigger fish, (2) juvenile black grouper and beaugregory, (3) lionfish, and (4) sheepshead.

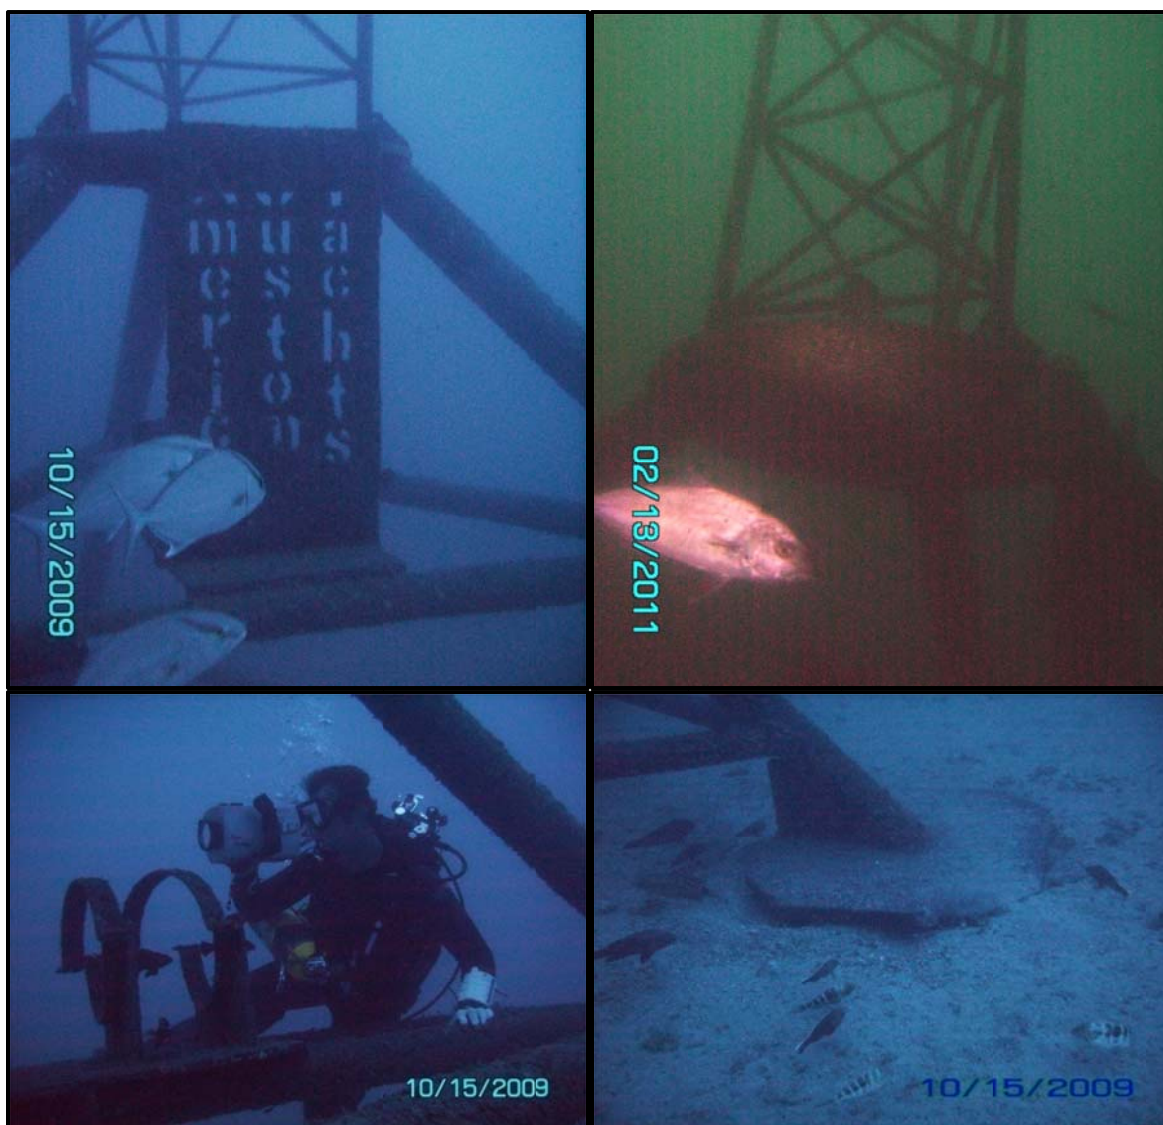
Figure 12. American Custom Yachts Tower 2009 & 2011 photographs.

The maximum seafloor depth at this artificial reef site is about 187 feet and the tower is 35 feet tall. The rope and barrels float upward about 90 feet from the top of the tower and may be as little as 70 feet beneath the surface in a mild current. The seafloor at this site is quite firm and composed of a shell/coarse sand mixture and appears to provide a solid base for the heavy tower, as scouring is not significant around the tower's three feet. The photographs in Figure 12 are from the monitoring dive and show general conditions of the reef and some of the species observed during the dive.

Identification of species in the photographs shown above in clockwise order from the upper-left photograph are (1) greater amberjacks, (2) greater amberjack, (3) black & bank seabass and juvenile snowy grouper, and (4) Rich Meeker with black seabass around brackets.

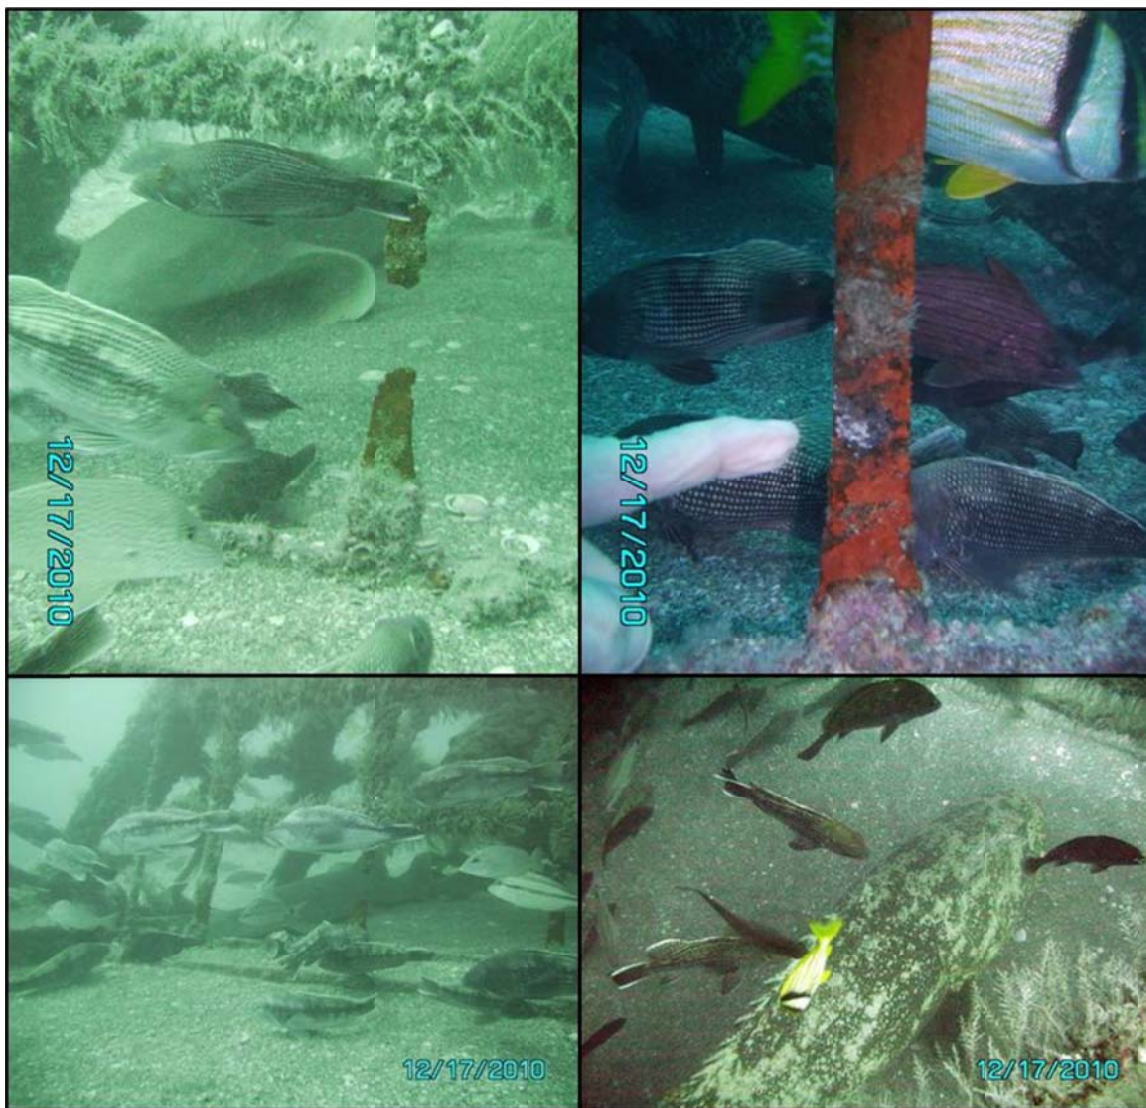
**Figure 14. Reefmaker Inlet Barge Artificial Reef photographs from 2010.**

Underwater measurements at each of the four units were performed; minimal settling of 1 ft has occurred and is typical of other Reefmaker Unit sites deployed by Martin County. The bases of all the units were buried resulting in increased stability. Figure 14 shows representative photographs of the Reefmaker units at the Inlet Barge site. All four of the Reefmaker units are intact and standing upright. Some of the steel bars near the base of the units have eroded/corroded through with some section loss evident as shown in the photographs of the Reefmaker steel damage; over time this erosion/corrosion is expected to worsen. In addition to showing the conditions of the reef, the photographs in Figure 14 show some of the species observed during the monitoring dive.

Identification of species in the photographs shown above in clockwise order from the upper-left photograph are (1) black seabass & nurse shark, (2) goliath grouper, porkfish, black seabass, and cubbyu, (3) goliath grouper, porkfish, and black seabass, and (4) black seabass and tomtates.

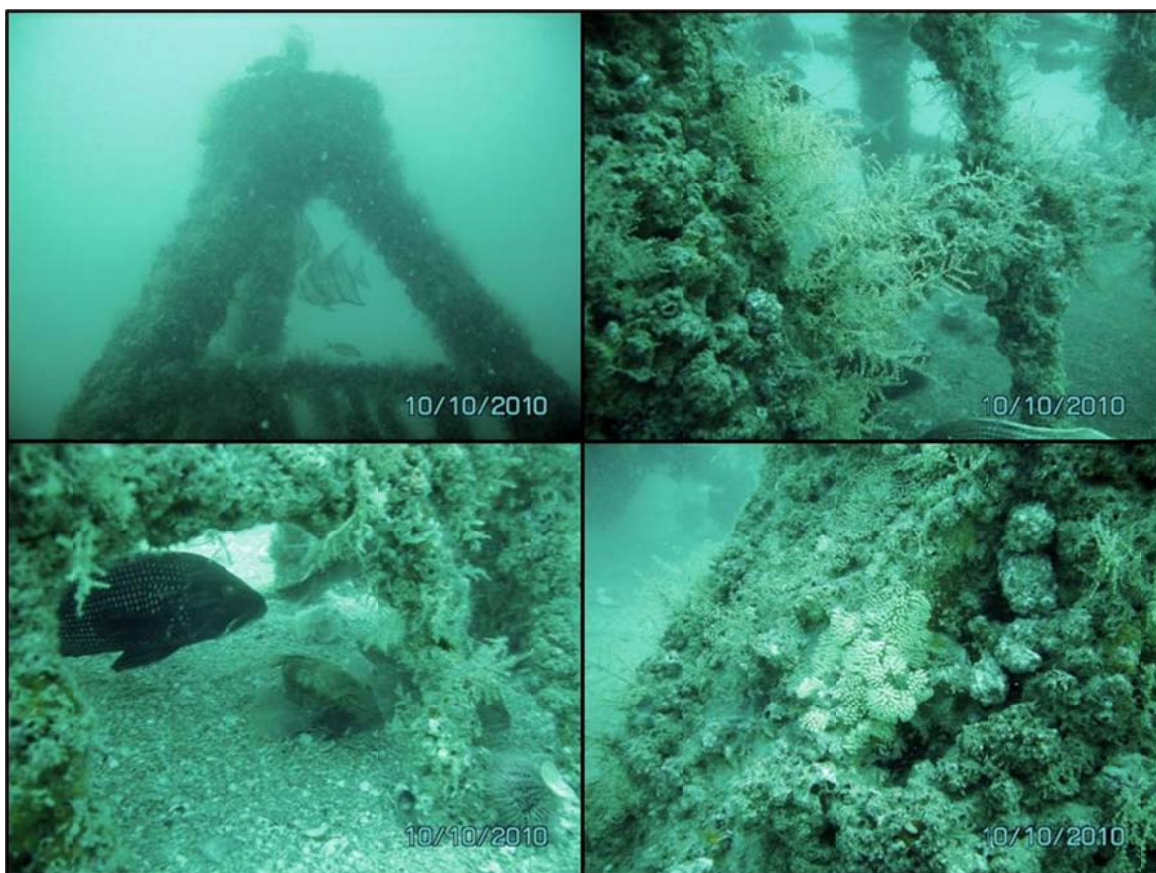
**Figure 16. Reefmaker Triangle Artificial Reef 2010 photos.**

Each of the modules at the Reefmaker Triangle location was observed and found to be standing upright, stable and in their original positions. Settlement of approximately 1 foot was noted around the base of one module although it appeared very stable. The concrete components of the modules were intact however several steel components (typically near the base of the units) were observed to be corroded/eroded severely as shown in the photographs below. The photographs in Figure 16 are from the monitoring dive and show general conditions of the reef and some of the species observed during the dive.

Identification of species in the photographs shown above in clockwise order from the upper-left photograph are (1) atlantic spadefish, (2) various marine benthic growth, (3) Unknown fish egg masses, and (4) black seabass.

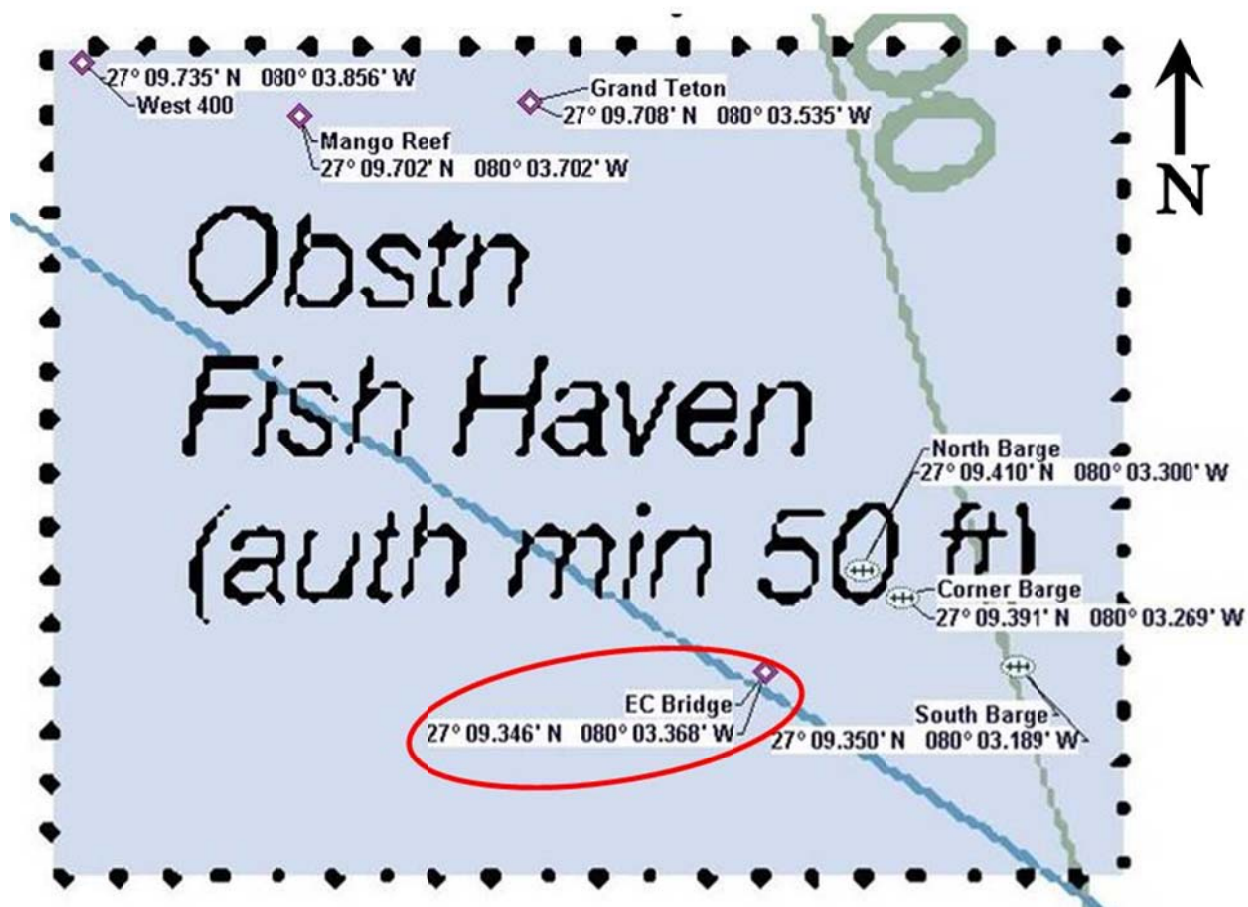
Figure 17. Chart view of the Evans Crary Bridge Reef within the Ernst Artificial Reef site.

Each barge load of these materials was deployed from one of two temporary mooring buoys placed approximately 100 to 200 yards west of three sunken barges previously sunk for artificial reef development in 1972. Because the contractor moored the barge each time to the same buoys, the materials settled on the bottom in a tightly grouped pile. This pile is roughly elliptical and measures approximately 280 feet long x 80 feet wide x 26 feet high, with the major axis in an east/west orientation.

The Evans Crary Bridge pile has become a thriving reef community with substantial populations of pelagic and benthic species. At the surface above the reef, baitfish by the 1000's are often seen at this site. This artificial reef site has become one of, if not the most visited artificial reef sites in Martin County for saltwater anglers, charter sport fishing boats, and recreational divers. Figure 17 shows the location of the Evans Crary Bridge Artificial Reef.

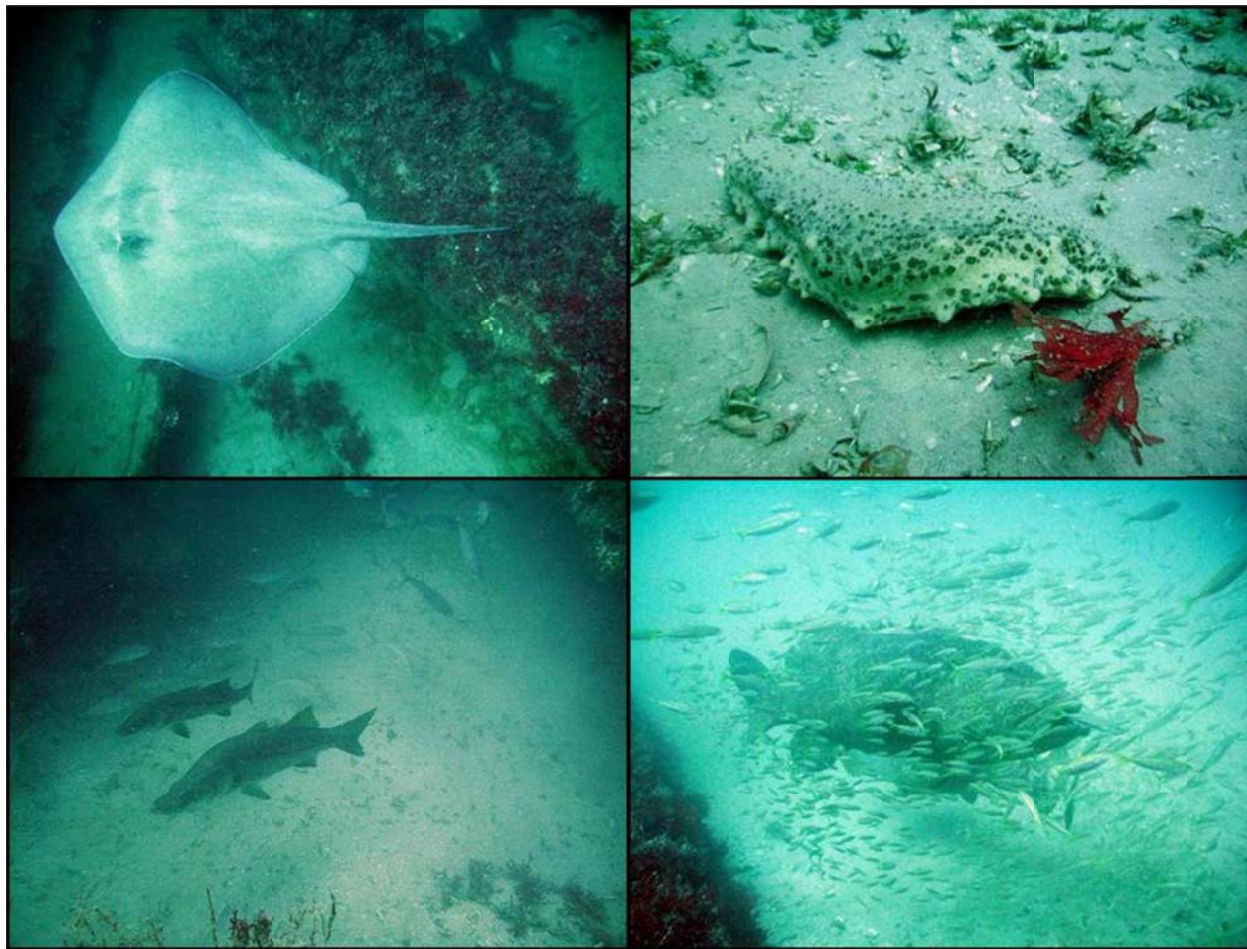
**Figure 18. Evans Crary Bridge Reef 2010 photographs.**

The overall structural stability of this site appears very good and should continue to be an excellent artificial reef site for many decades to come. The photographs in Figure 18 are from the monitoring dive and show general conditions of the reef and some of the species observed during the dive.

Identification of species in the photographs shown above in clockwise order from the upper-left photograph are (1) southern stingray, (2) variegated sea cucumber, (3) goliath grouper and round scad, and (4) common snook and tomtates.

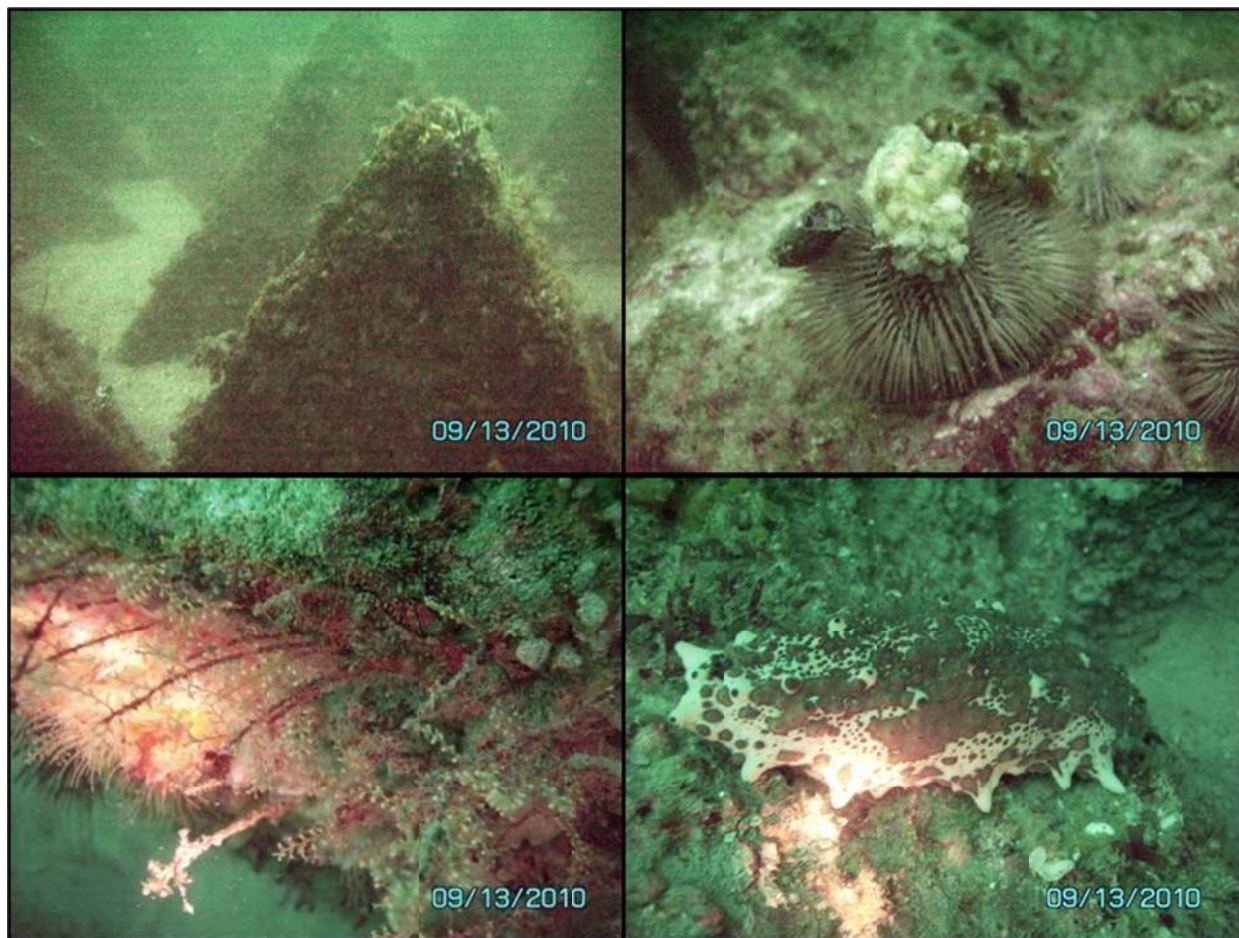
**Figure 20. Tetrahedron Stack Artificial Reef 2010 photographs.**

After initially diving this site in 2001 during the post-deployment surveys, and monitoring the site many times during the years 2001 – 2006; very little has changed as far as structural integrity and module positioning is concerned. A slight visual settling of the modules has occurred of maybe 1 foot but with depth gages and dive computers of plus/minus 1-foot accuracy it is hard to quantify. Overall assessment is that the reefs structural stability is good and little changes have occurred since deployment in 2001, despite the several hurricanes experienced in the area during 2004 and 2005. The photographs in Figure 20 are from the monitoring dive and show general conditions of the reef and some of the species observed during the dive.

Identification of species in the photographs shown above in clockwise order from the upper-left photograph are (1) no fish in this photo, (2) sea urchin, (3) variegated sea cucumber, and (4) marine benthic growth.

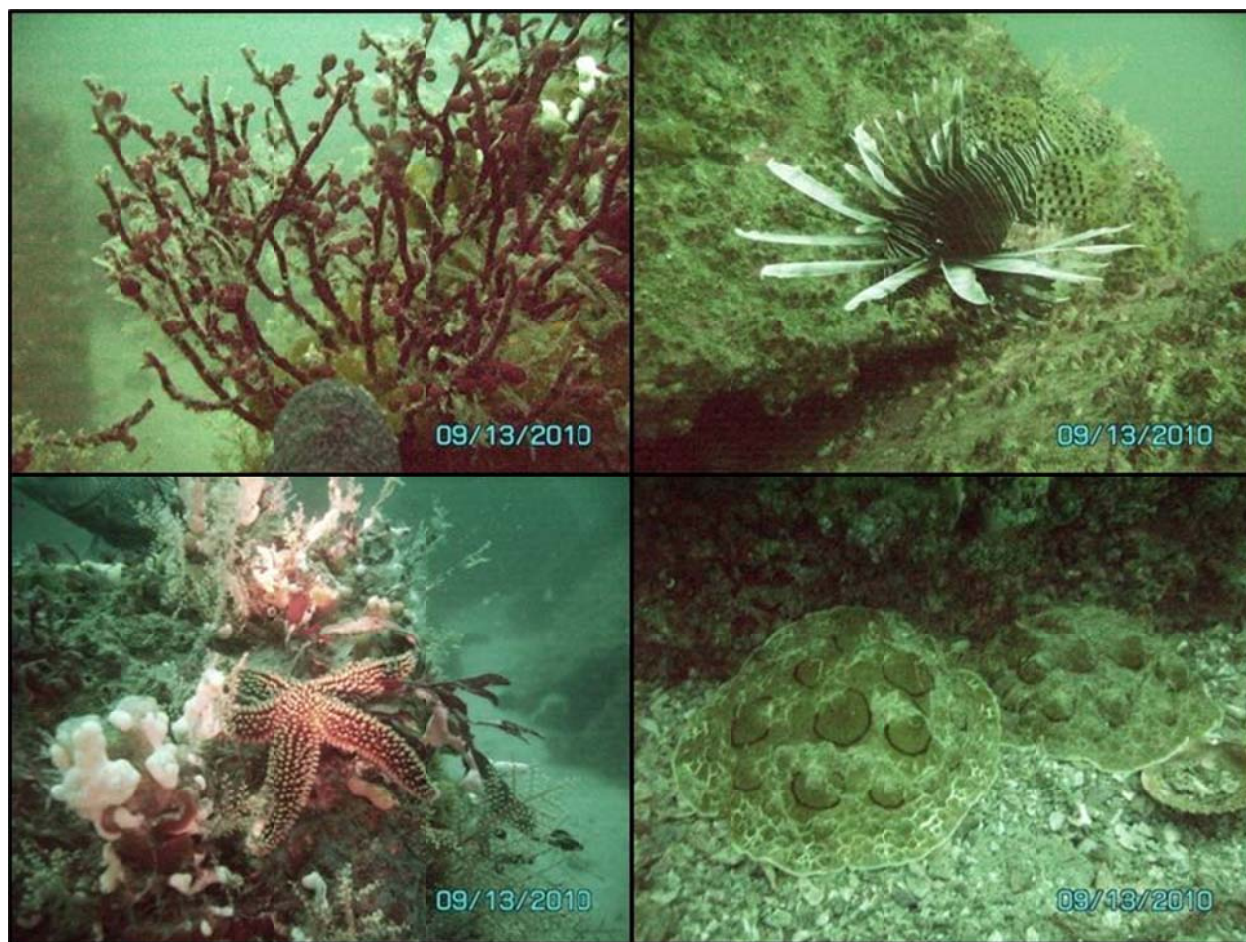
**Figure 22. Tetrahedron Patch Yellow & Blue Artificial Reef 2010 photographs.**

This site was first monitored in 2002 during the post-deployment surveys and then for 5 years as a part of the 2003 – 2007 annual monitoring events. As was seen at the Tetrahedron Stack Reef, very little has changed as far as structural integrity and positioning/location of the modules is concerned. Minimal amount of settlement of the modules has been observed during the surveys, approximately 1 to 2 feet, but with depth gages and dive computers of plus/minus 1-foot accuracy it is hard to quantify. The overall assessment is that the reefs structural stability is good and little changes have occurred since the deployment in 2002, despite the 3 hurricanes experienced during 2004 and 2005. The photographs in Figure 22 are from the monitoring dive and show general conditions of the reef and some of the species observed during the dive.

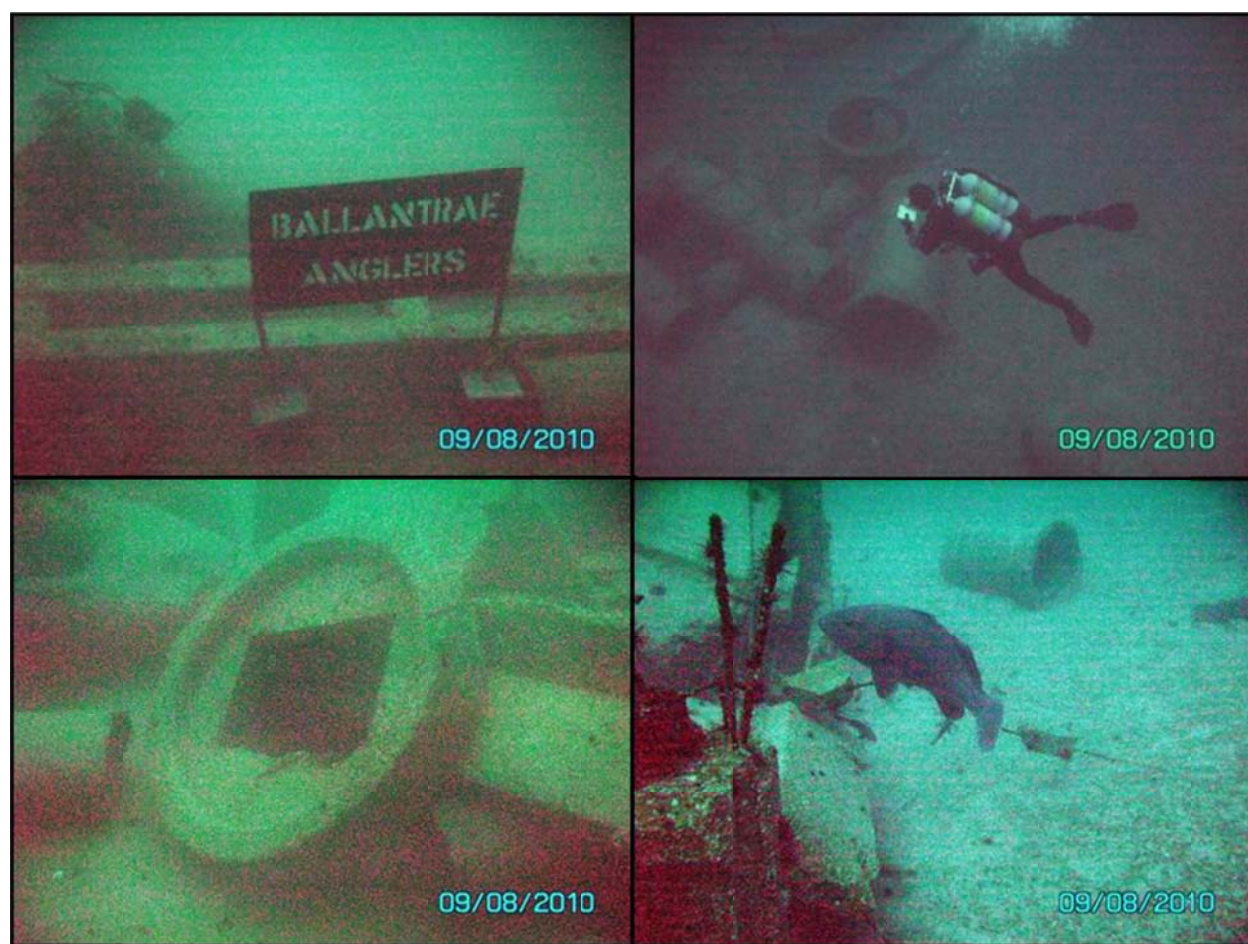
**Figure 24. Ballantrae Anglers Reef 2010 photographs.**

At this depth scouring is not a problem because of all the firm stable substrate and minimal effect from wave energy found here. However During the deployment many of the pieces did land on top of each other and formed a low mound with an approximate 6 ft profile. No settling or loose components were observed. The photographs in are from the monitoring dive and show general conditions of the reef and some of the species observed during the dive.

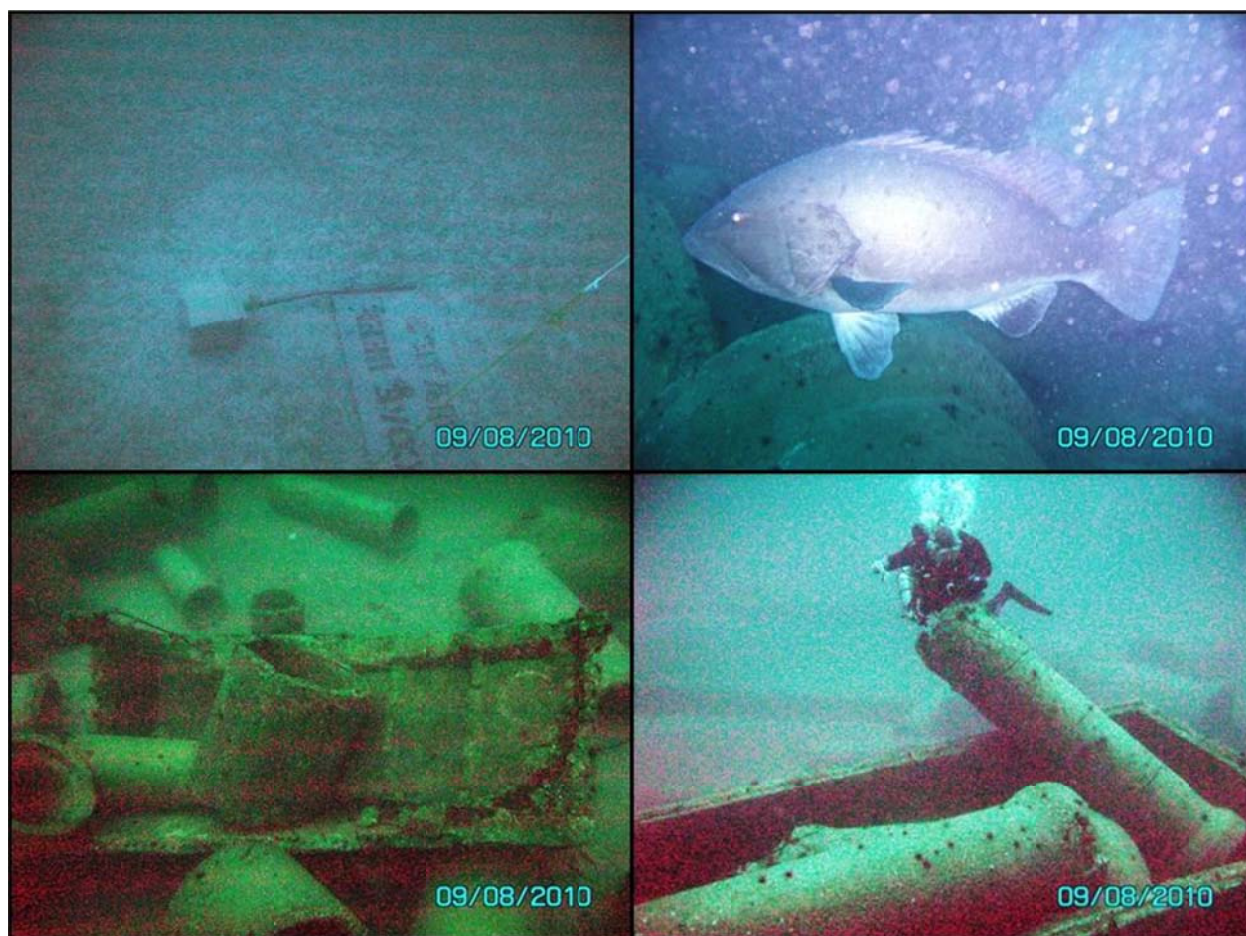
**Figure 26. Pirate's Cove Reef photograph from 2010.**

This reef is comprised of several hundred pieces of concrete: large baffle boxes, pilings, bridge railings, culverts, slabs and smaller concrete chunks. During the deployment several of the large baffle boxes landed on top of each other greatly increasing the overall profile of the reef. Many other components landed in a similar fashion and resulted in a high mound with a 15 ft profile. When deeper reefs are built from deploying from an anchored barge some scattering occurs. This seemed not to be the case with this reef, although there are a few pieces laying on the seafloor a short distance (< 50 ft) from the main mound. The footprint of the site is generally round and occupies about ½ acre of seafloor. At this depth, 187 ft, scouring is not a problem because of all the firm stable substrate and minimal wave energy at these depths. No settling or loose components were observed. The photographs in are from the monitoring dive and show general conditions of the reef and some of the species observed during the dive.

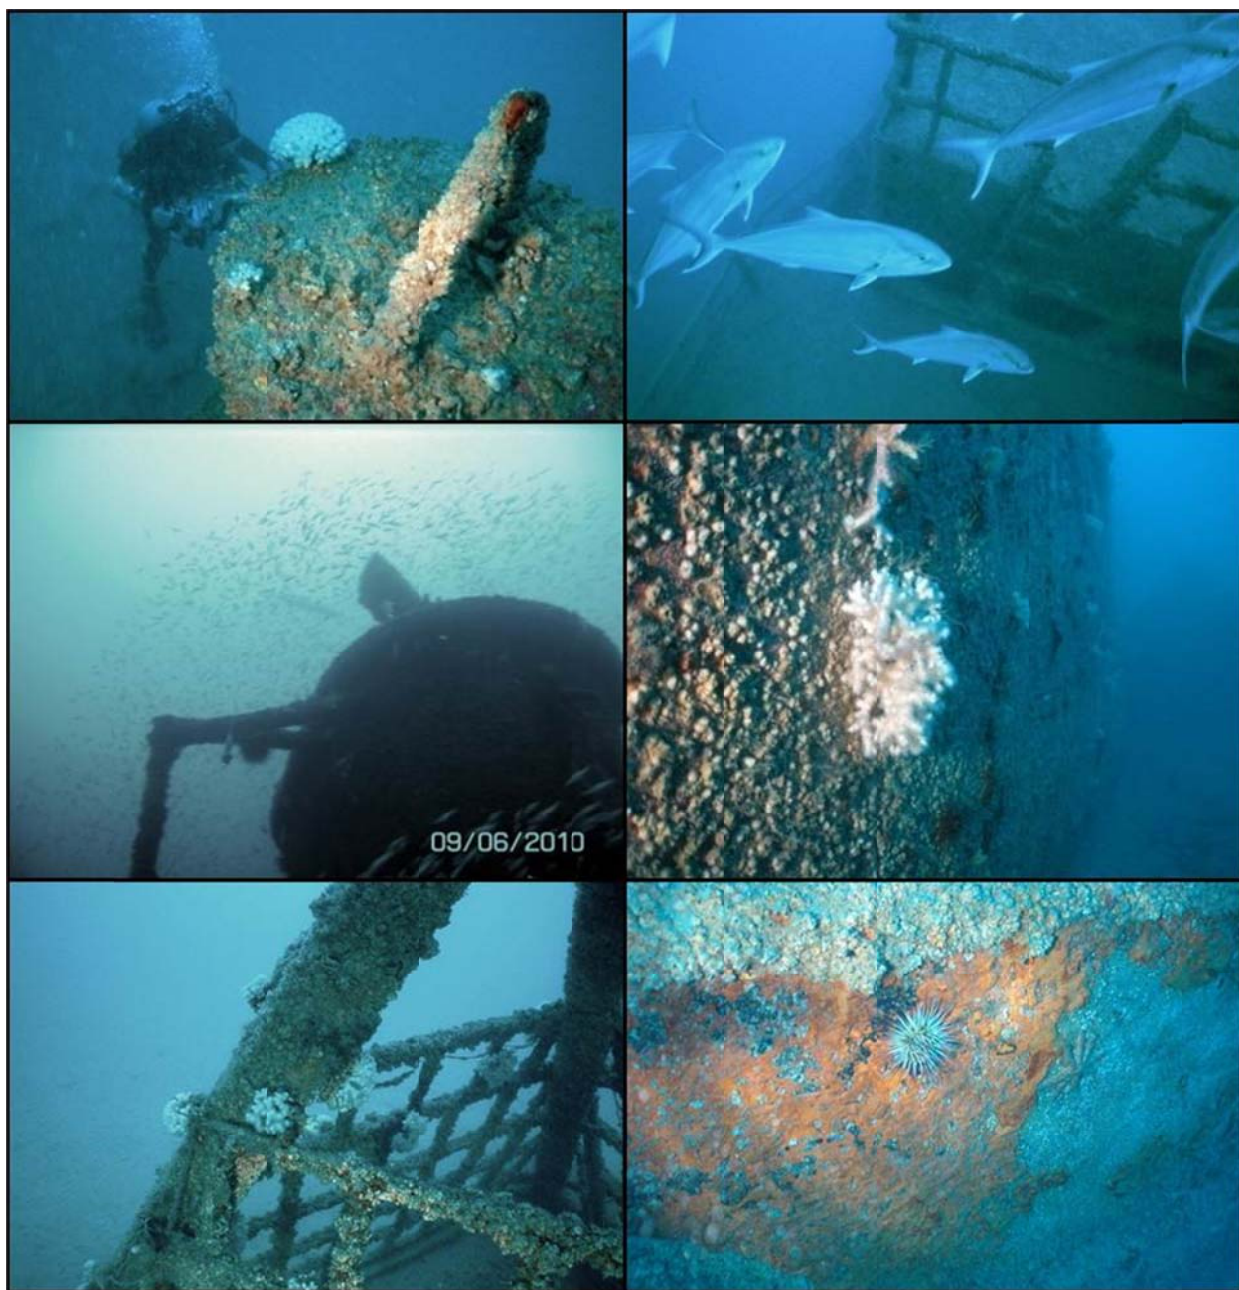
**Figure 28. Wickstrom Artificial Reef photographs from 2010.**

- The Wickstrom was broken in two sections just aft of the main superstructure.
- The two sections were separated by approx. 15 to 30 ft in a jagged separation

- Cracks exist on other areas of the ship from either the initial deployment impact or the hurricanes or both
- The DGPS derived Lat/Long coordinates of the site have not changed at all

Since 2005 no further structural changes have been located during annual monitoring efforts. Figure 28 and Figure 29 display photographs taken during the 2010 monitoring survey showing the Wickstrom's superstructure, *Oculina* corals growing, large schools of fish surrounding the reef and the general conditions of the reef observed during the dive.

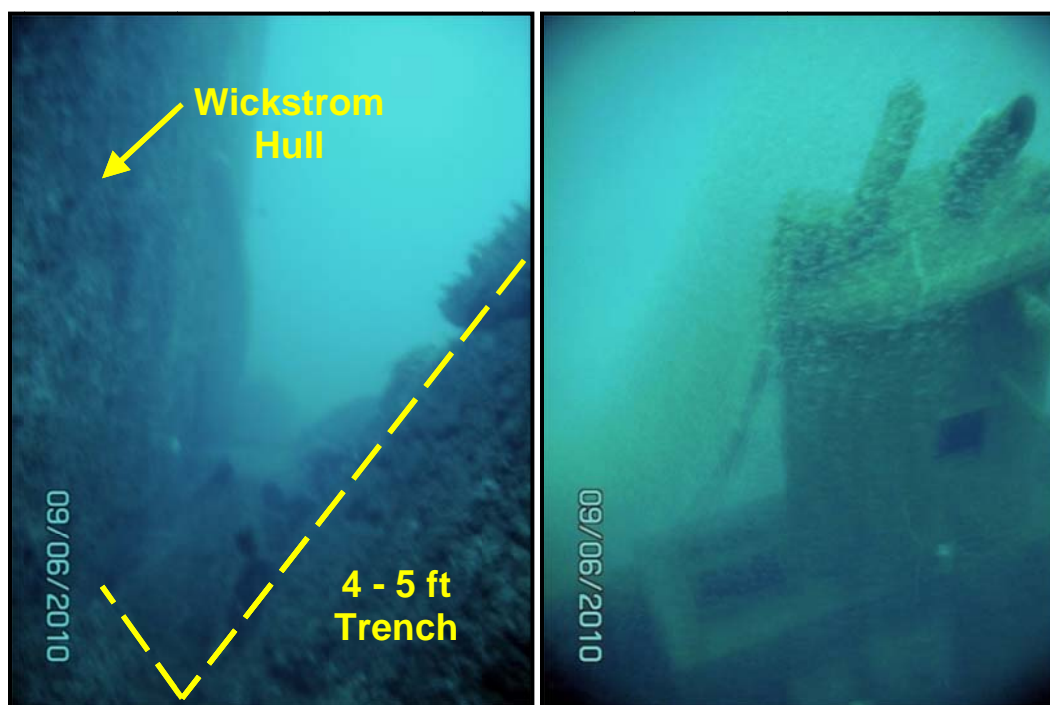
As mentioned above, Figure 29 shows the trench (left photo) carved into the bottom by the ship as a result of repetitive motion of the ship's hull on the bottom substrate. The photograph on the right shows 1000's of baitfish schooling around the smoke stack funnel of the Wickstrom.

Figure 29. Wickstrom hull groove cut into the sea floor (Left), Wickstrom superstructure (Right).
