2011 ANNUAL MONITORING REPORT

MARTIN COUNTY ARTIFICIAL REEFS

14 AUGUST 2012

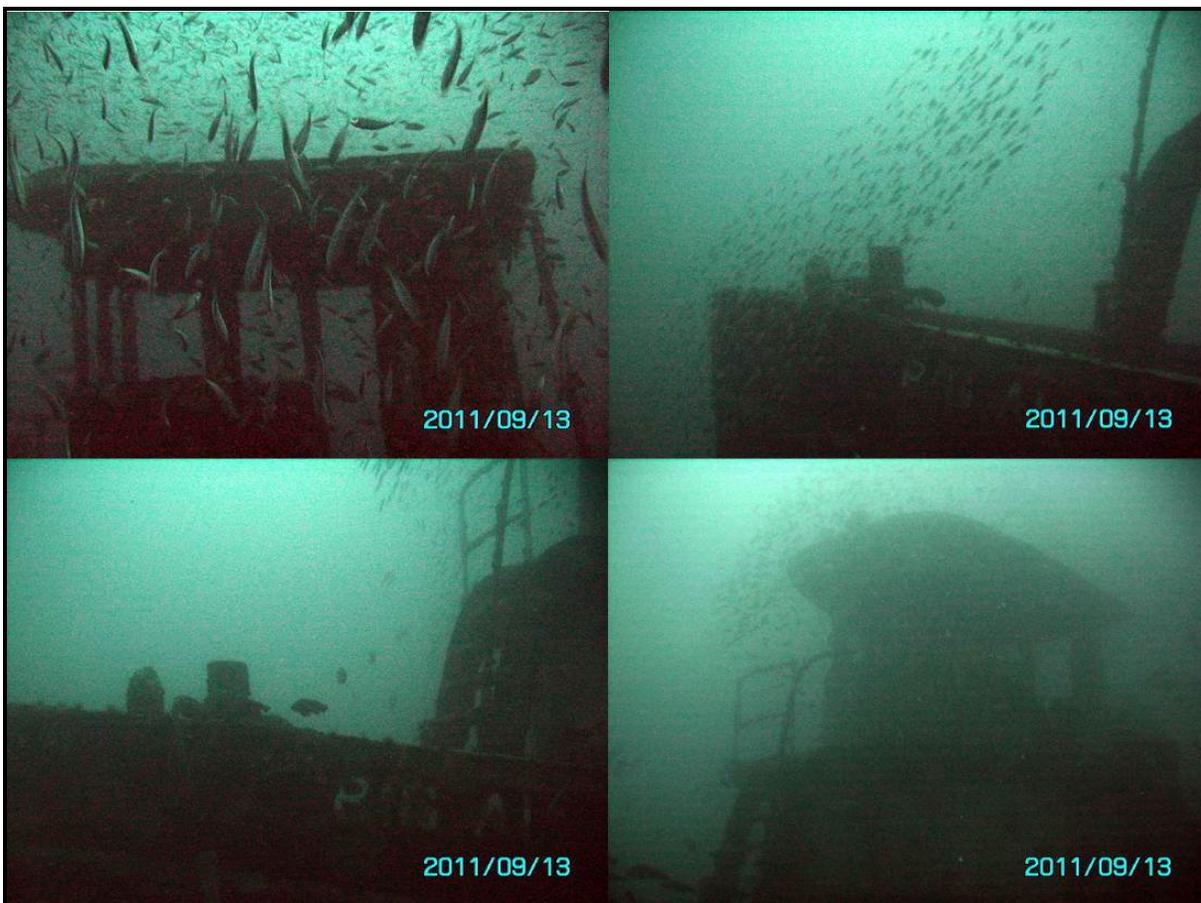
Figure 6. Glasrud Artificial Reef 2011 photographs.

The Glasrud appears to have suffered very little damage to the hull as it impacted the seafloor. During the deployment video cameras were attached to the railing on the aft wheelhouse deck to record the sinking. From the audio of that recording we were able to time the descent, 187 feet, to the seafloor. The tugboat took a total of 14 seconds to sink to the bottom once it had submerged. The video shows an explosion of bubbles and debris from the seafloor as the tugboat hit the bottom. Other than the steel sign bolted to the top of the wheelhouse being bent over at the legs from the impact, the tugboat was in good structural condition. The photographs in Figure 6 show the general condition of the Glasrud and some of the large schools of round scad observed around the vessel during the monitoring dive.

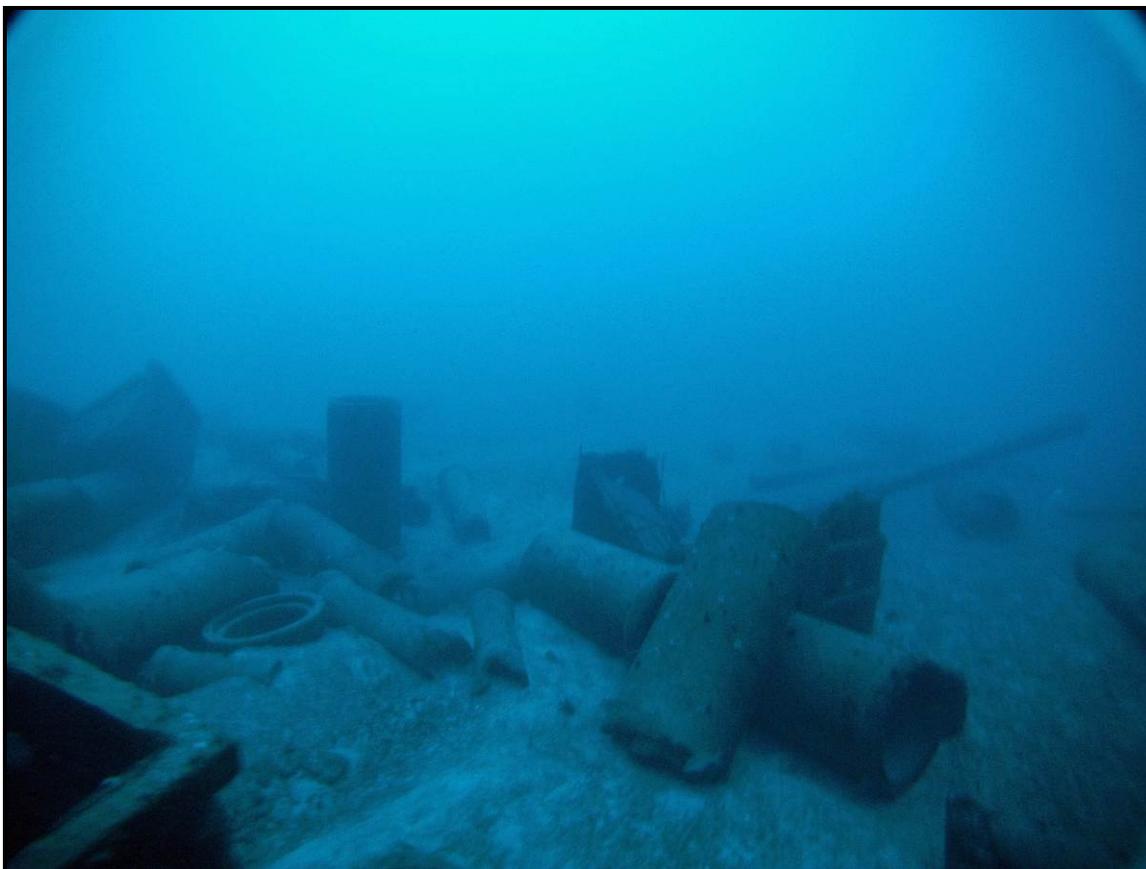
Figure 8. Pirate's Cove Artificial Reef 2011 photograph.

During the 2011 monitoring no major changes were observed to have occurred since the 2010 monitoring. Baffle boxes are still stacked on top of each other providing a high profile of 15 ft. No major scouring exists at the site and materials are still in a tight grouping. As opposed to the shallower artificial reefs that can be effected by large ocean swells and seasonal sediment shifting, the deep water sites seem to only be effected by hurricanes with very large (>3 meter) long period swells. Since the construction of the artificial reef in 2009 no major hurricanes have hit the area. The photograph in Figure 8 shows the general condition of some of the materials observed during the monitoring dive of Pirate's Cove Reef.

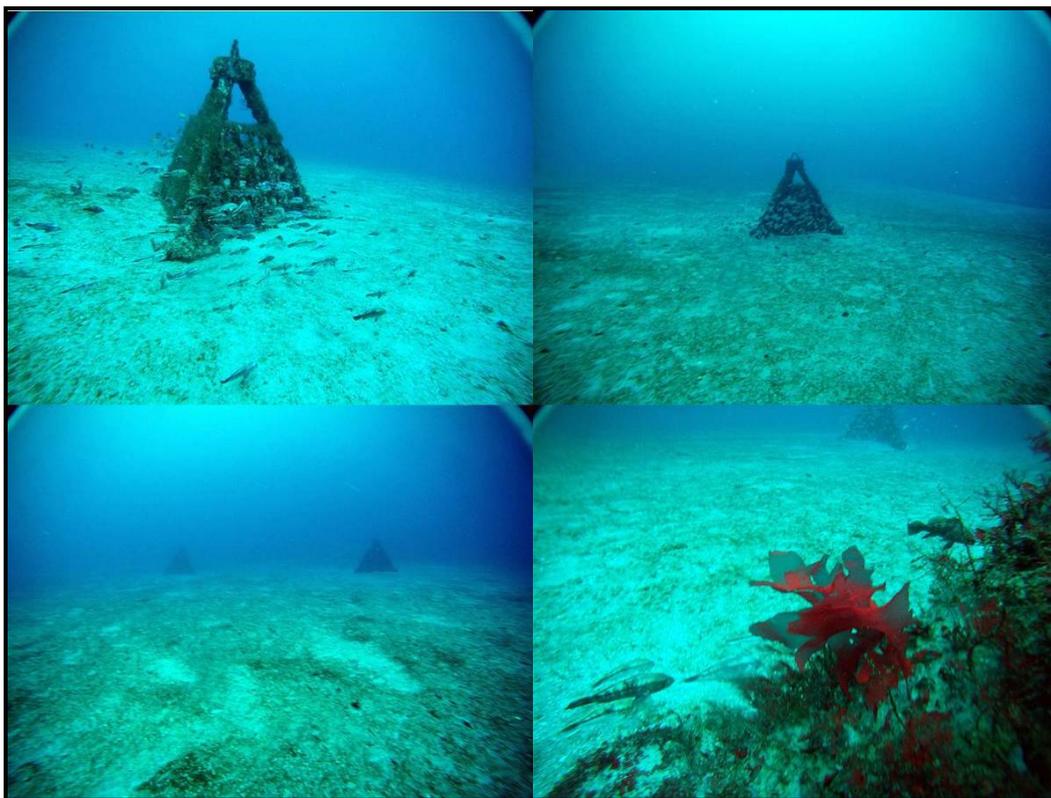
Figure 10. Reefmaker Patch - North 2011 photographs.

These 5 Reefmaker units were deployed at a depth of 101 ft and although this site received a direct hit from Hurricane Wilma (Category 2) in Oct. 2005, five months after the deployment of the units, all 5 units have remained stationary. The only noticeable change overtime has been some steel corrosion and erosion on the lower 2 ft. of the steel side panels. This is minor as compared to other Reefmaker units deployed in 60 feet or less which show severe corrosion and erosion probably resulting from higher oxygen content, increased wave action and sand abrasion.

The concrete appears to be holding up well with little sign of deterioration. Each of the 5 units has settled into the seafloor a nominal 1-foot, therefore reducing the total profile from 10 ft. down to 9 feet. The photographs in Figure 10 show the general condition of the Reefmaker Patch - North and the area surrounding the Reefmakers observed during the monitoring dive.

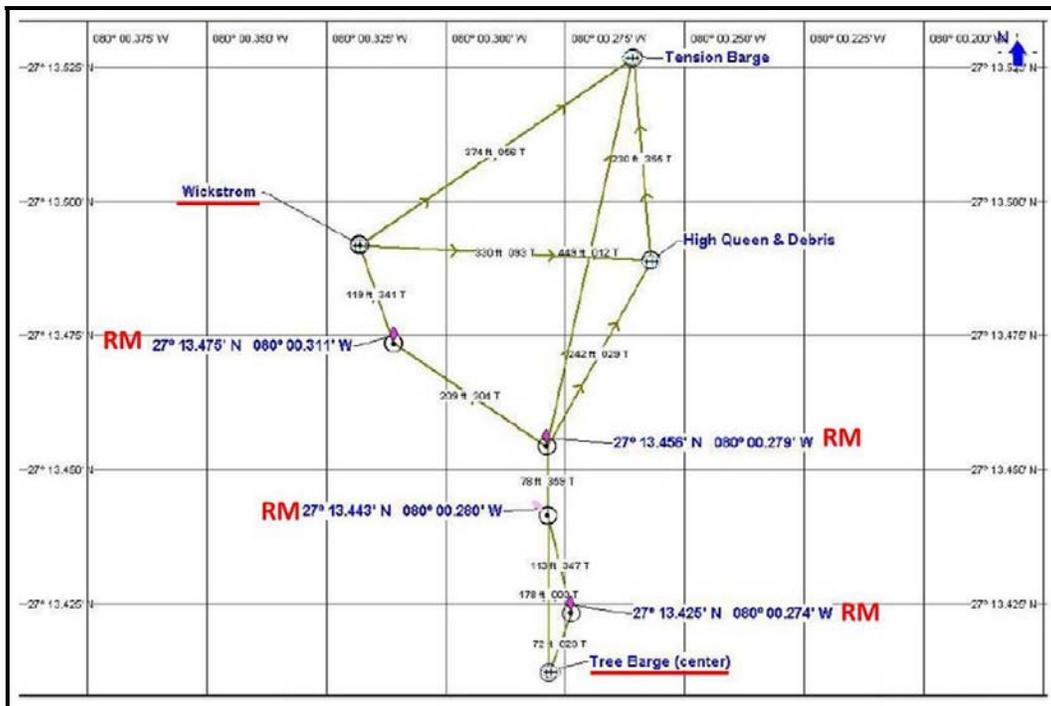
In May 2005, four Reefmaker units were deployed in a line between the Tree Barge and the Wickstrom as a part of an FWC grant that placed sixty Reefmaker units throughout the Donaldson and Sirotkin artificial reef sites. Four of the Reefmaker units were placed between the Tree Barge and Wickstrom to provide a corridor between the two artificial reefs for fish and tech divers. The closest Reefmaker unit was placed approximately 72 ft NNE of the Tree Barge. Figure 11 shows the location of the Tree Barge in the Sirotkin Artificial Reef area and Figure 12 shows the locations of the nearby Reefmaker units between the Tree Barge and the Wickstrom.

Figure 12. Sirotkin Reefmaker Corridor from the Tree Barge to the Wickstrom.

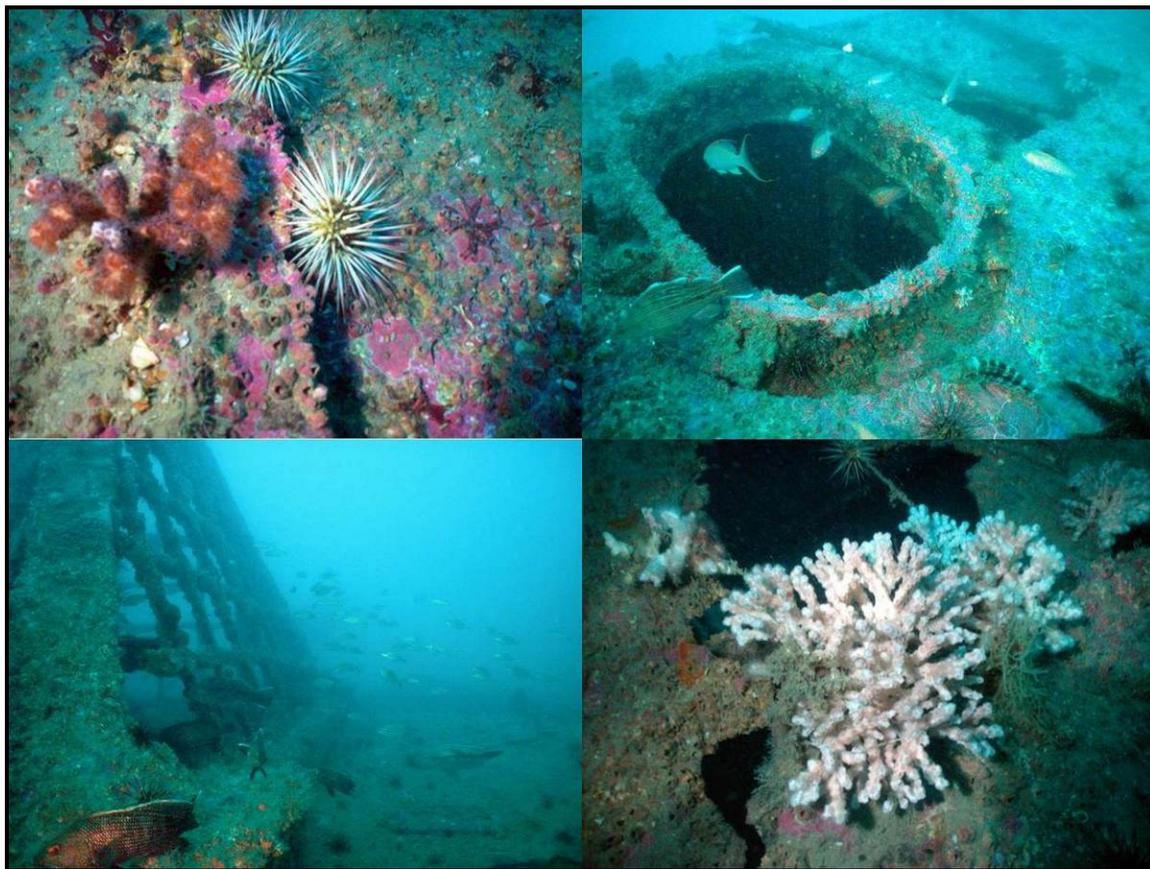
Figure 13. Tree Barge Artificial Reef photographs from 2011.

As mentioned above, the Tree Barge shows some hurricane damage to the north center part of the steel deck plates. A large (30 ft. by 12 ft.) section of steel deck was observed having been peeled back lying on top of itself. The Tree Barge otherwise appeared structurally sound, the steel support members show little change except for some marine growth. The photographs in

Figure 13 show the general condition of the Tree Barge, the Reefmaker unit closest to the Tree Barge and some of the species observed during the monitoring dive.

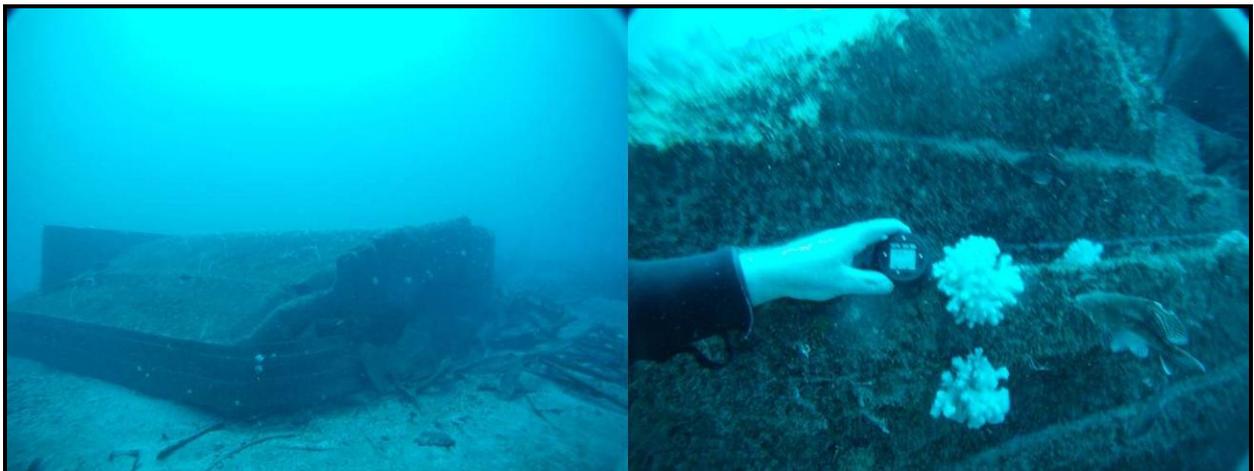
Figure 15. High Queen and Zeppo Artificial Reef 2011 photos.

An assessment of the artificial reef shows that both raked ends of the Zeppo are partially collapsed probably caused when it hit the seafloor. The intact hull of the Zeppo is upside down and cracks in the hull can be seen at each end. A pre-deployment inspection of the Zeppo revealed existing cracks in the hull. There is no way to determine which, if any, cracks are new, but as found with most barges used for artificial reef materials eventually the barge will begin to collapse as the side plates give way to the forces of the ocean environment. The photographs in Figure 15 show the general condition of the High Queen and Zeppo reef observed during the monitoring dive.

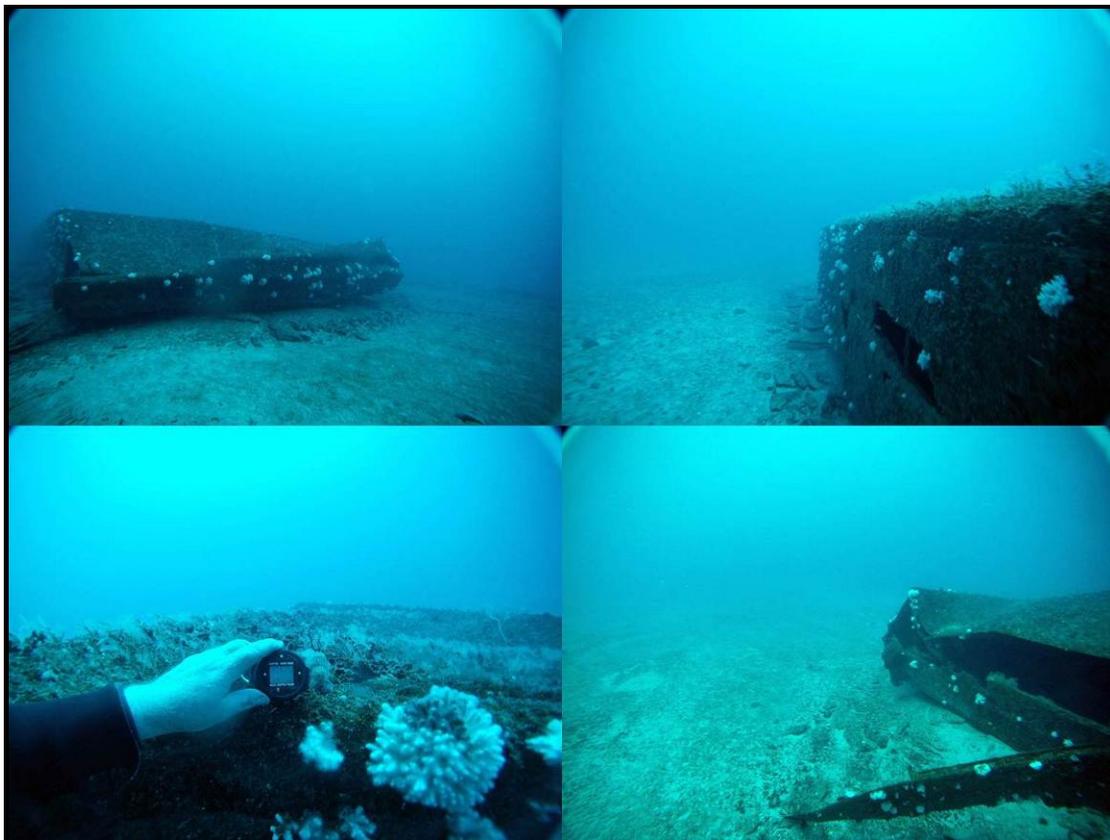
Figure 17. Tension Barge Reef 2011 photographs.

The Tension Barge lies completely upside down in a north/south orientation. Unlike the High Queen/Zeppo about 100 yards to the south, the Tension Barge's deck is flat on the seafloor. The side hull plates of the barge are buckled in many places, but otherwise it is intact. The steel is heavily rusted and small holes exist in many places on the hull and sides. In contrast to the High Queen/Zeppo, the Tension Barge has very little complexity. Fish were seen swimming into the holes that allow access to the dark confines of the barge's interior. Over time it is expected the sides will collapse allowing much more surface area to become available for marine life to occupy. The photographs from the monitoring dive in Figure 17 show the general condition of the Tension Barge as it sits on the seafloor.

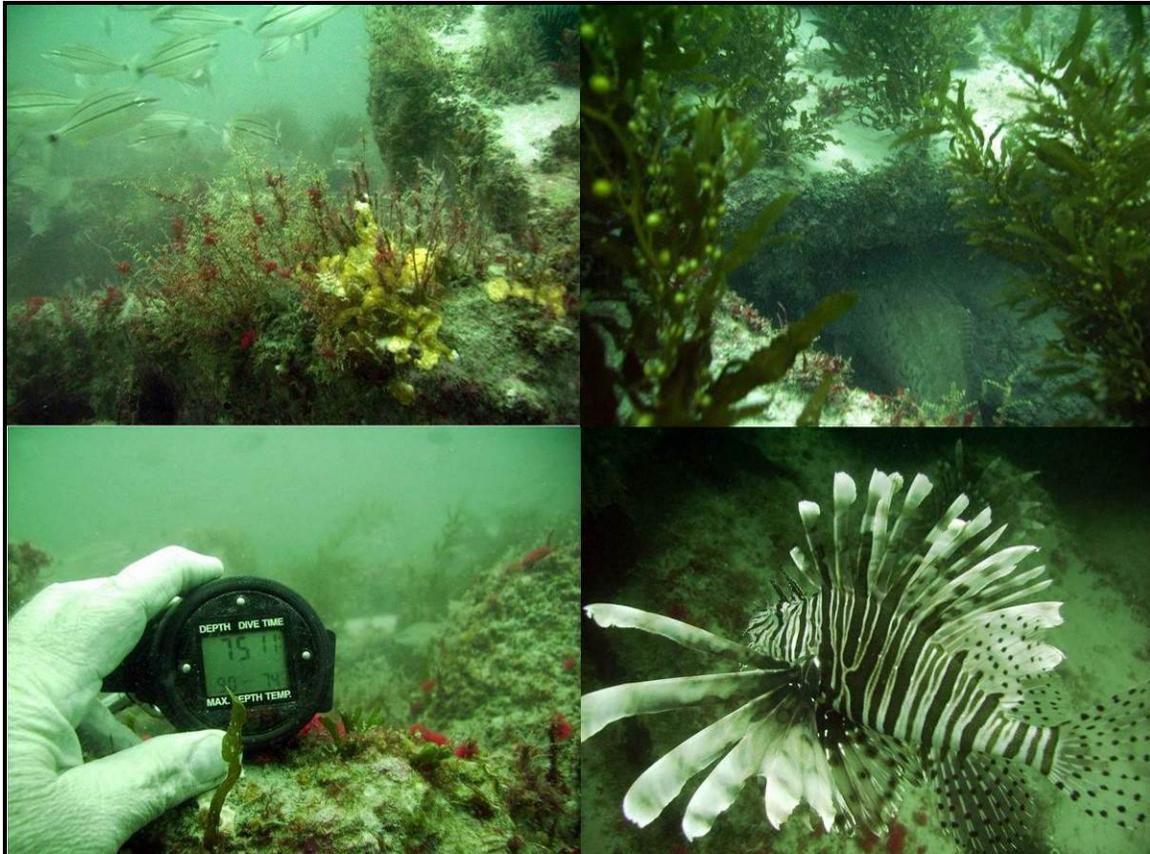
Figure 19. Concrete Railroad Tie Stack Reef 2011 photographs.

Overall it appears the reef has changed very little since the last monitoring in 2009. The structure is a mound of concrete railroad ties with a complex arrangement of surfaces and voids. The depth to the highest part of the pile was measured at 73 ft in 2011, one foot deeper than in 2009 which could be due to the shifting of material over time. In comparison to previous dives on this reef it appeared that the slope of the mound had decreased slightly, although this could not be confirmed. The photographs in Figure 19 show the general condition of the Concrete Railroad Tie Stack Reef and some of the species observed during the monitoring dive including a school of tomtates and a lionfish.

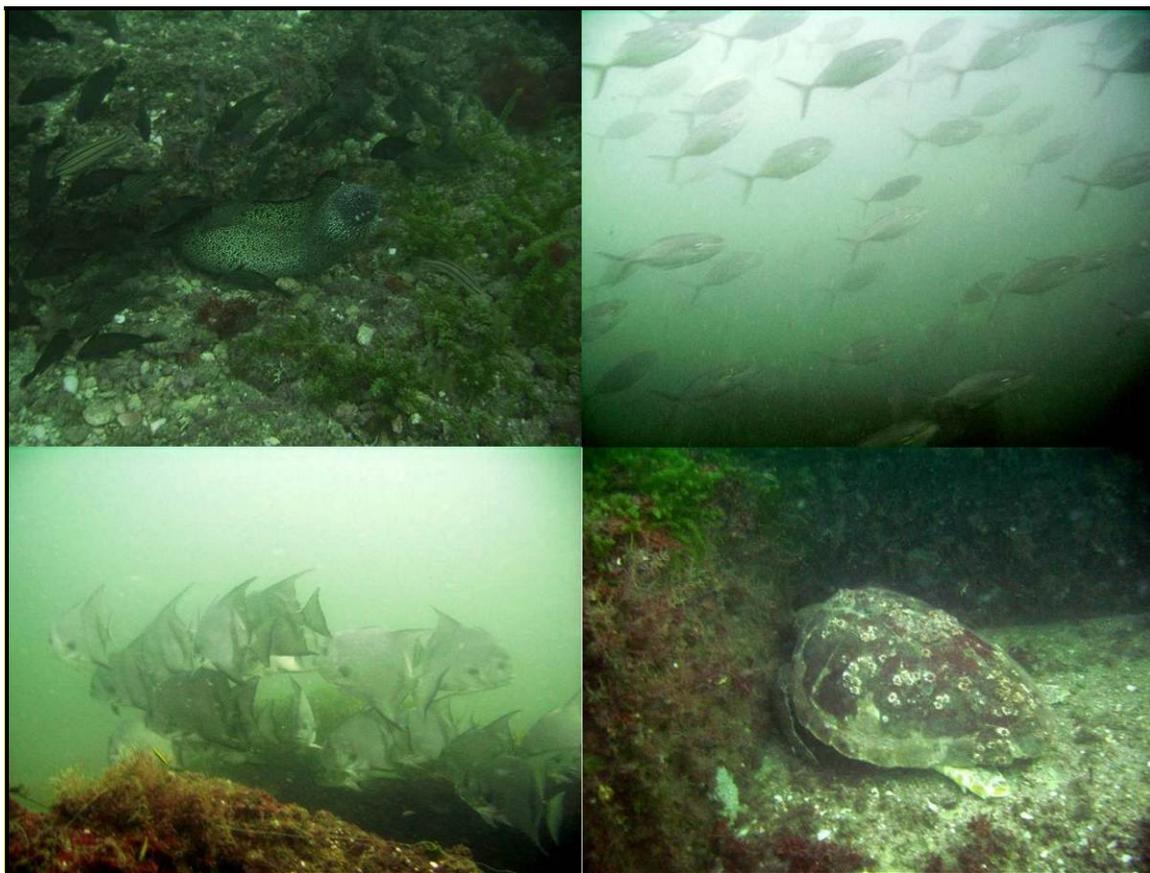
Figure 21. Texas Reef 2011 photographs.

The steel and concrete portion of the Texas Reef sits just east of the uppermost summit of the Texas Reef where the reef starts to slope downward. So far all components appear to be holding up well with the exception of anticipated corrosion of the steel components. Because of the shallow characteristic of this site, much seasonal shifting of sediments occurs resulting in some changes in appearance over time. Although this is a dynamic site it appears to be doing very well as an artificial reef as the biological section below describes. The photographs in Figure 21 show the general condition of this section of the Texas Reef and some of the species observed during the monitoring dive.

Identification of species in the photographs shown above in clockwise order from the upper-left photograph are (1) spotted moray eel, (2) bar jacks, (3) loggerhead turtle, and (4) spadefish.

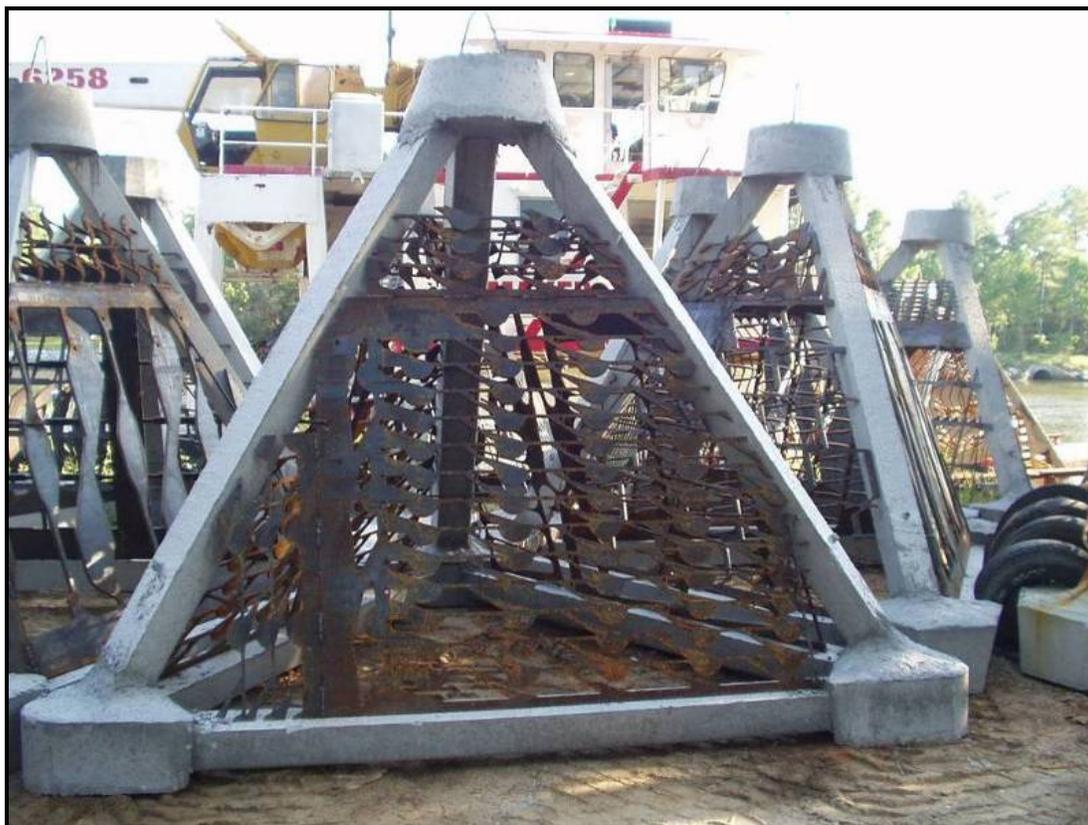
Figure 22. Reefmaker “Florida Special” artificial reef units.

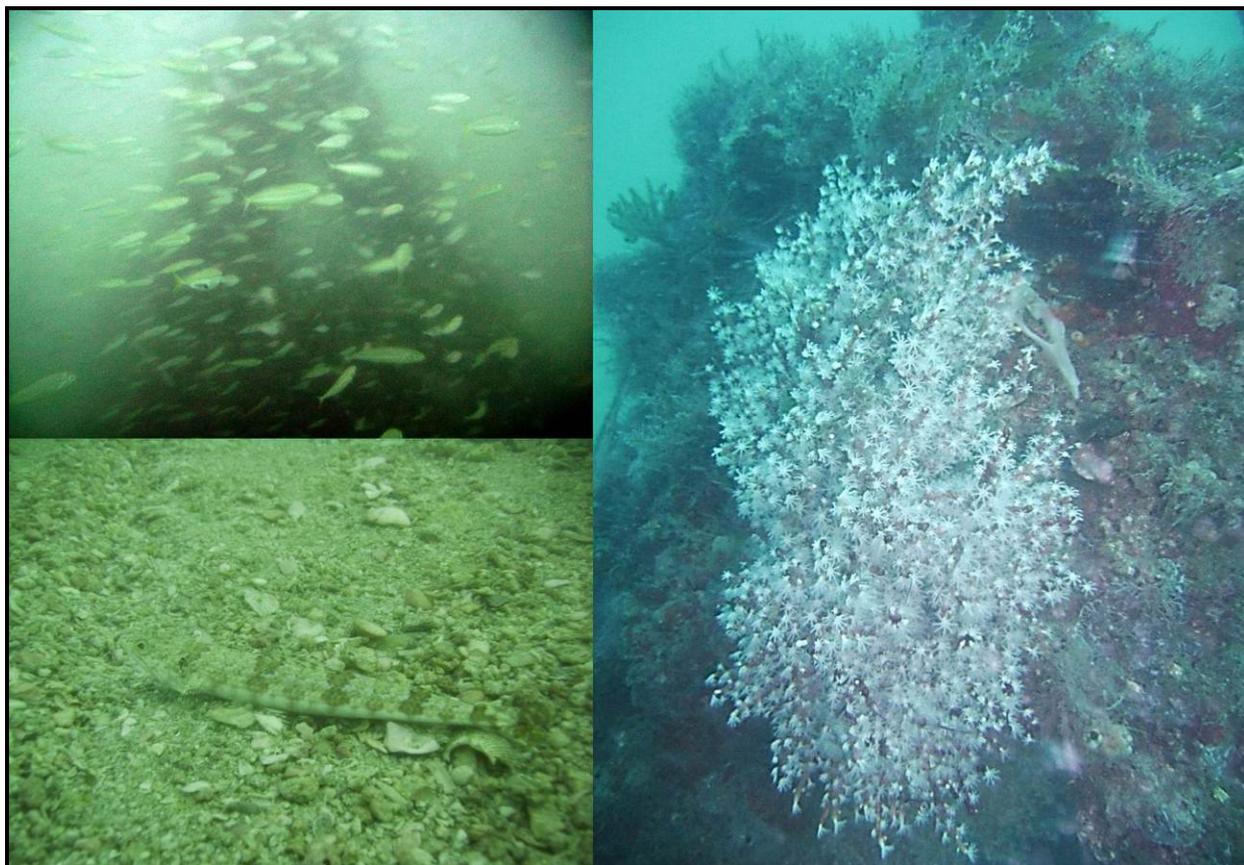
Figure 24. Texas Reef - Reefmaker 2011 photographs.

It was also observed that some of the steel sidepieces are corroding and eroding away in the lower portion (within several feet of the seafloor interface) of the Reefmaker units. This is believed to be caused by high currents in this area, the high oxygen content in the water because of shallow depth, and the constant movement of coarse sand on the bottom. These factors are thought to be contributing to a higher rate of corrosion and erosion of the steel components of these Reefmaker units. No movement other than slight settling has occurred since deployments in 2005. The photographs in Figure 24 show the general condition of the Texas Reef – Reefmaker units and some of the species observed during the monitoring dive.
