## FIELD OBSERVATION REPORT

**DATE:** October 27, 2017

**RE:** **FIELD OBSERVATION REPORT FOR THE MARINE RESOURCE AND STRUCTURAL SURVEY OF THE TETRAHEDRON PATCH (BLACK) ARTIFICIAL REEF IN MARTIN COUNTY, FLORIDA**

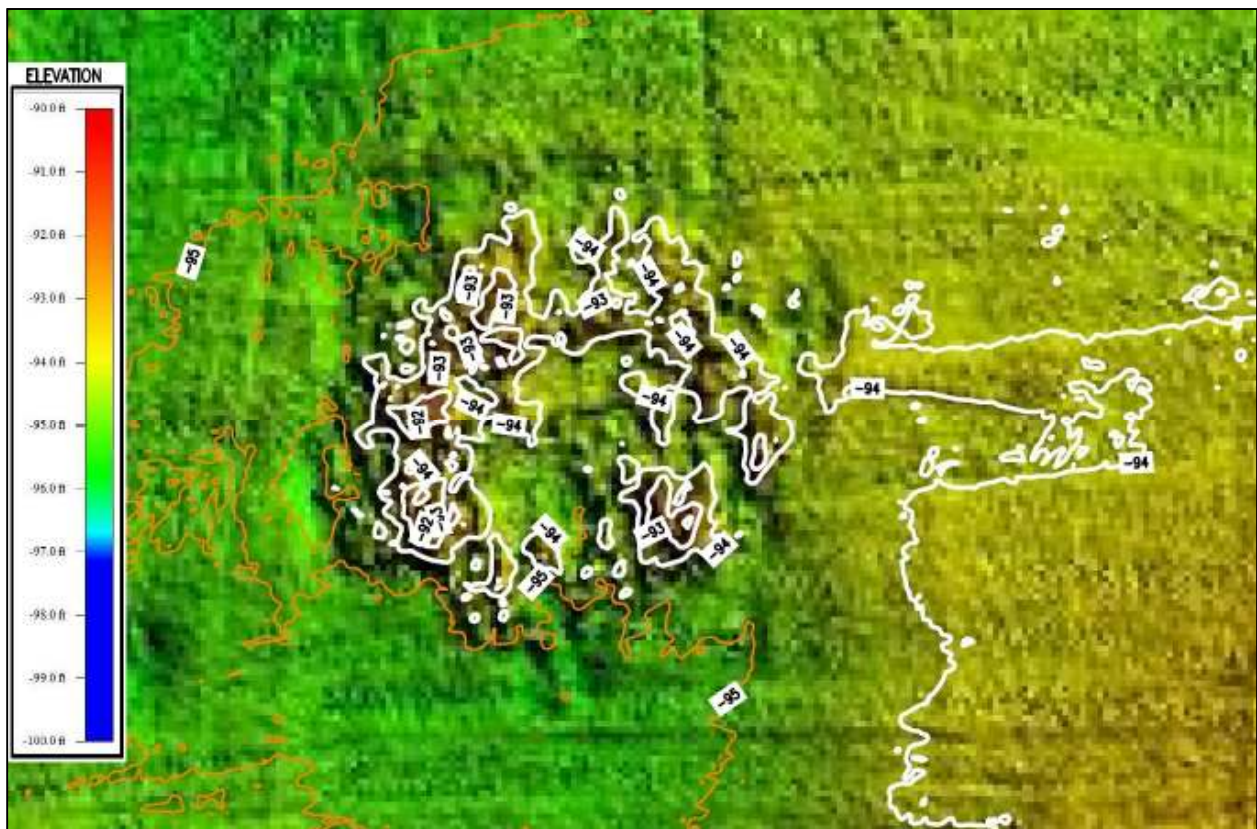
The multi-beam survey of the Reef was completed on June 28<sup>th</sup>, 2017. The Tetrahedron Patch (Black) artificial reef is approximately 70 feet in diameter. Water depths within the artificial reef area ranged from 92 to 95 feet deep at the time of the survey, with the shallowest water occurring on the west and southwest edges of the artificial reef (Figure 2).

**Figure 2.** An overview of the Tetrahedron Patch (Black) artificial reef depths and the layout of the concrete modules.

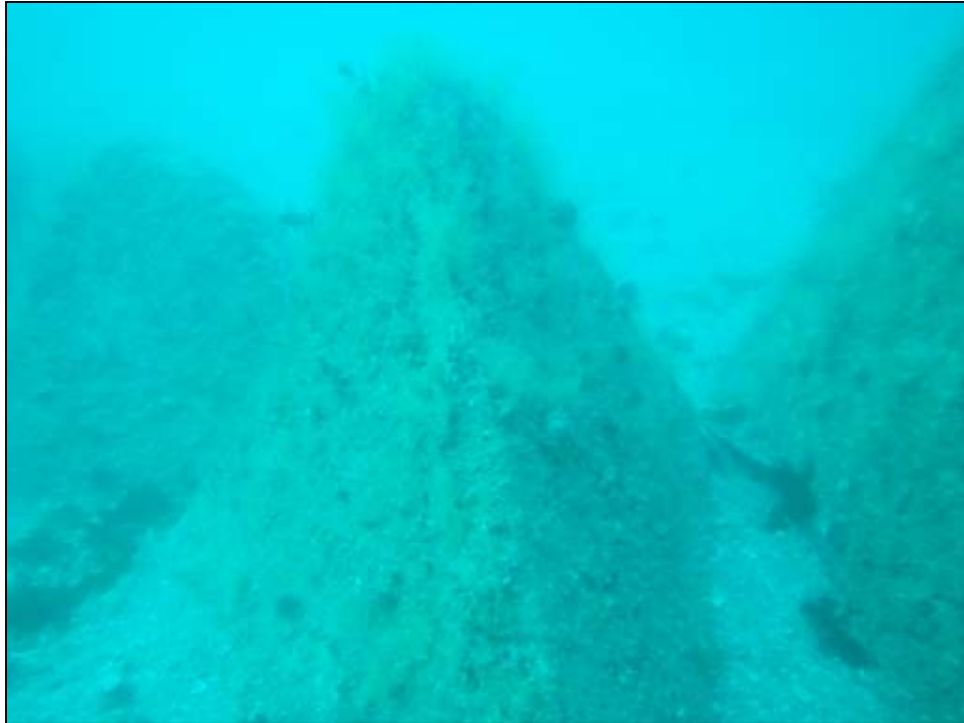
The individual tetrahedron concrete modules are solid concrete units, weighing up to 3600 lbs. each at the surface. The concrete components of the tetrahedron modules were intact (Photograph 1); and there was no noticeable damage to the modules. However, numerous small patches of debris were observed at the base of modules as shown in Photograph 2. There was some noticeable sinking into the bottom of the structures observed during the survey as shown in Figure 3. Many tetrahedron concrete modules have been partially buried into the sand, due to either sinking of the module, or the accumulation of sand.

**Photograph 1.** A frontal view of the tetrahedron concrete module at the Site.

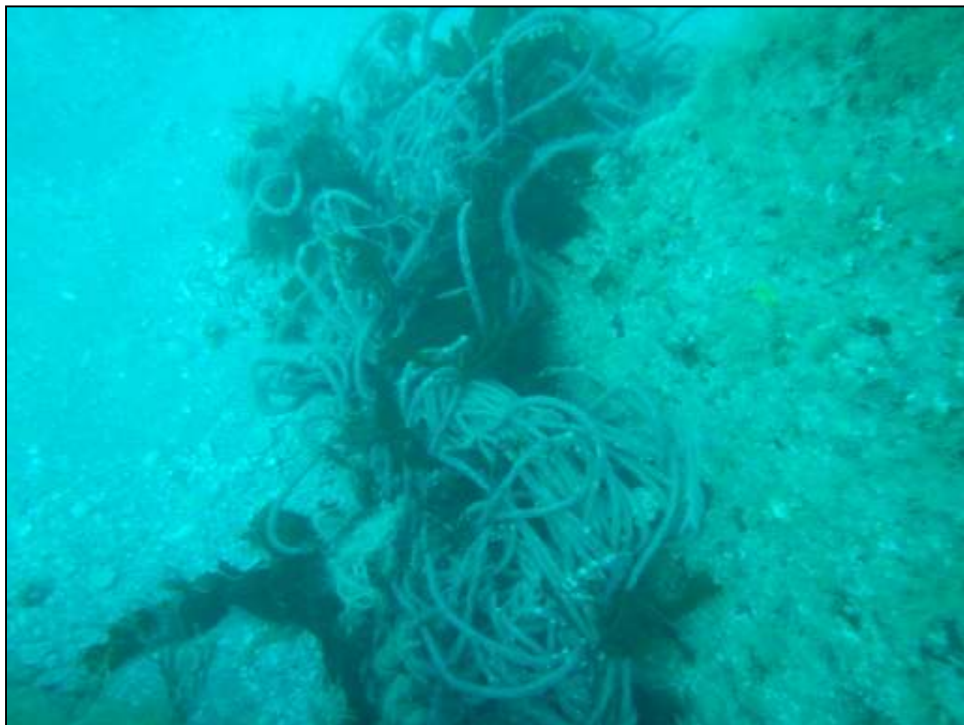
**Photograph 2.** Tangled line and rope at the base of modules was frequently observed during the survey.

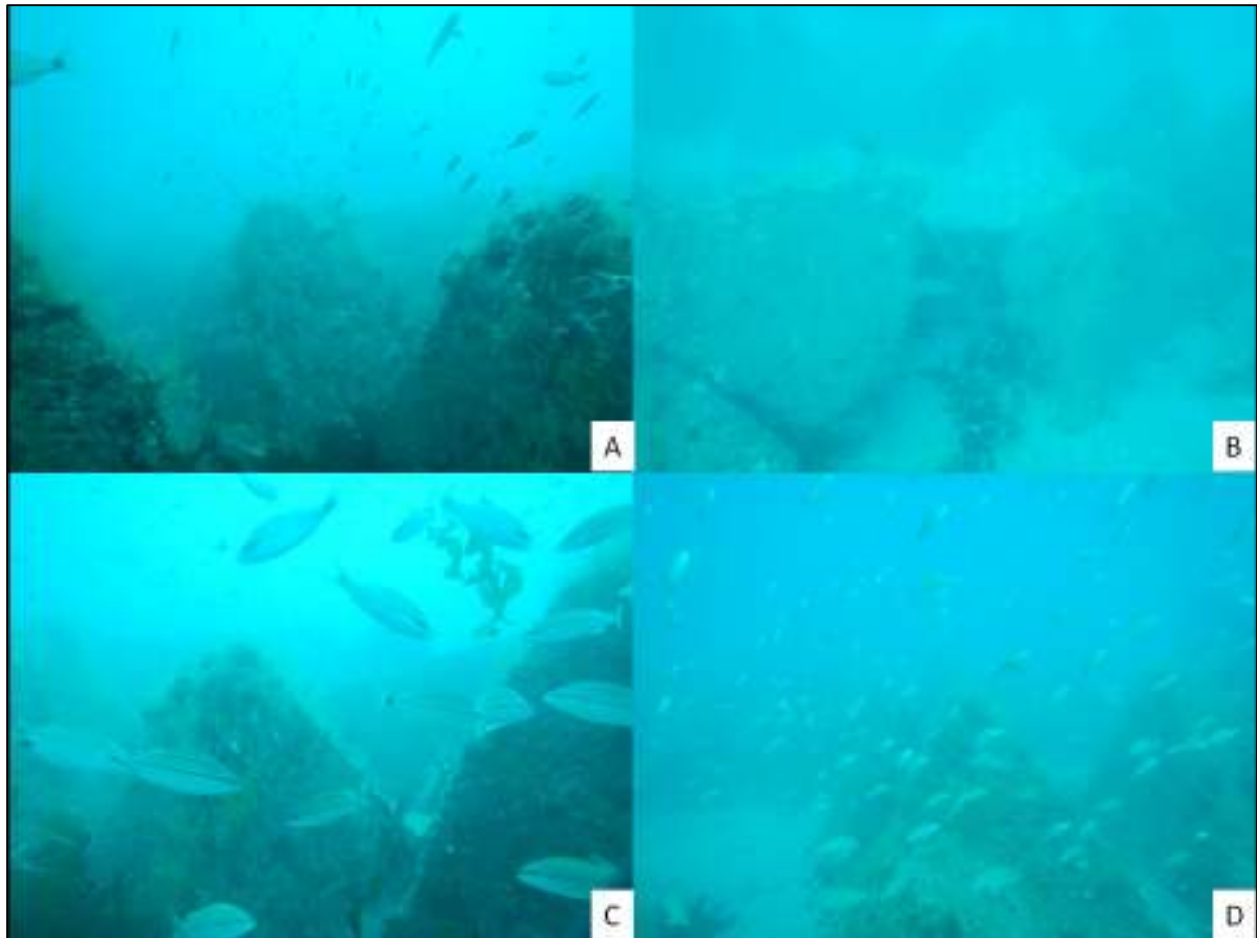
**Figure 3.** An overview of the Tetrahedron Patch (Black) artificial reef looking north (A), south, (B), east (C), and west (D) from the tallest observed point on the reef.

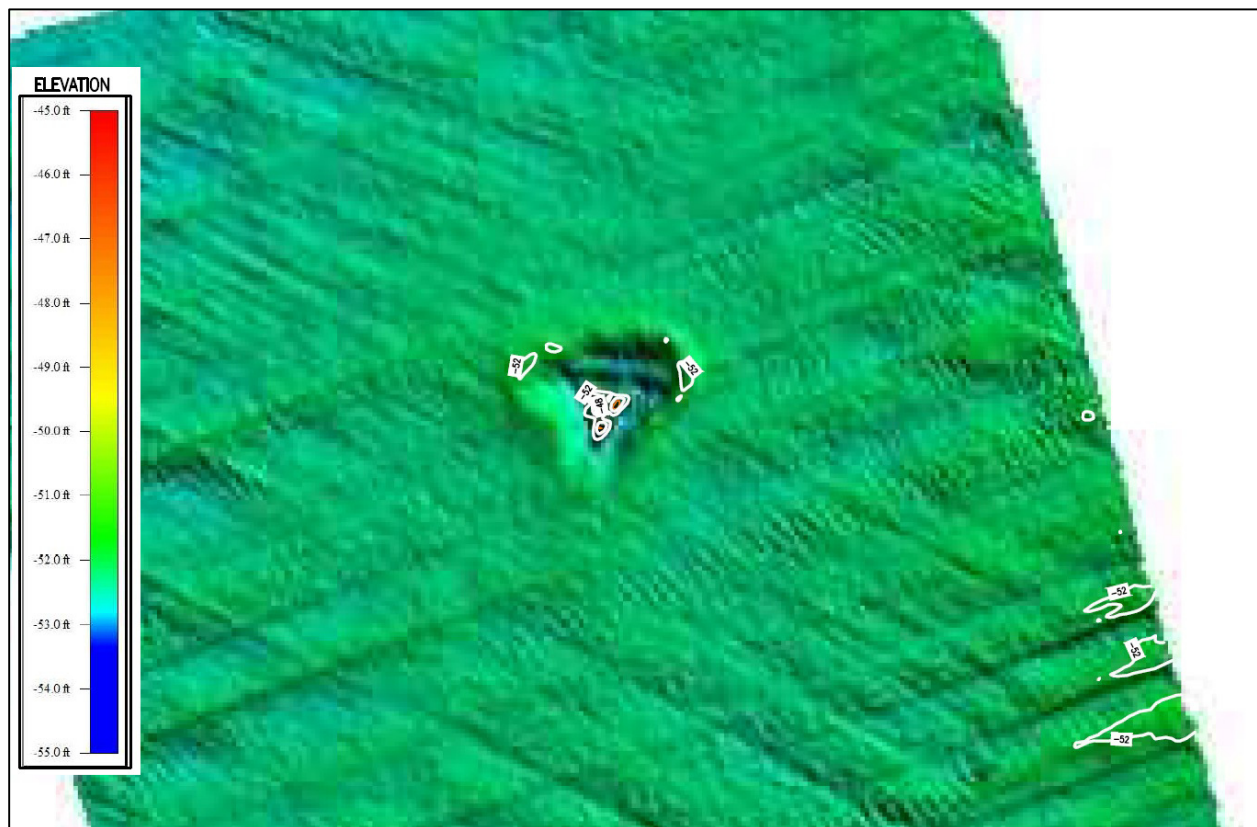
The multi-beam survey of the Donaldson Triangle - Reefmaker module was completed on June 28<sup>th</sup>, 2017, and showed the module is approximately 13.5 feet in diameter. Water depths around the artificial reef module were consistent and were 53 feet deep to the base of the Reefmaker module. The water depth was measured as 48 feet deep at the top of the artificial reef module (Figure 2).

**Figure 2.** An overview of the Donaldson Triangle - Reefmaker artificial reef depths and the layout of the concrete modules.

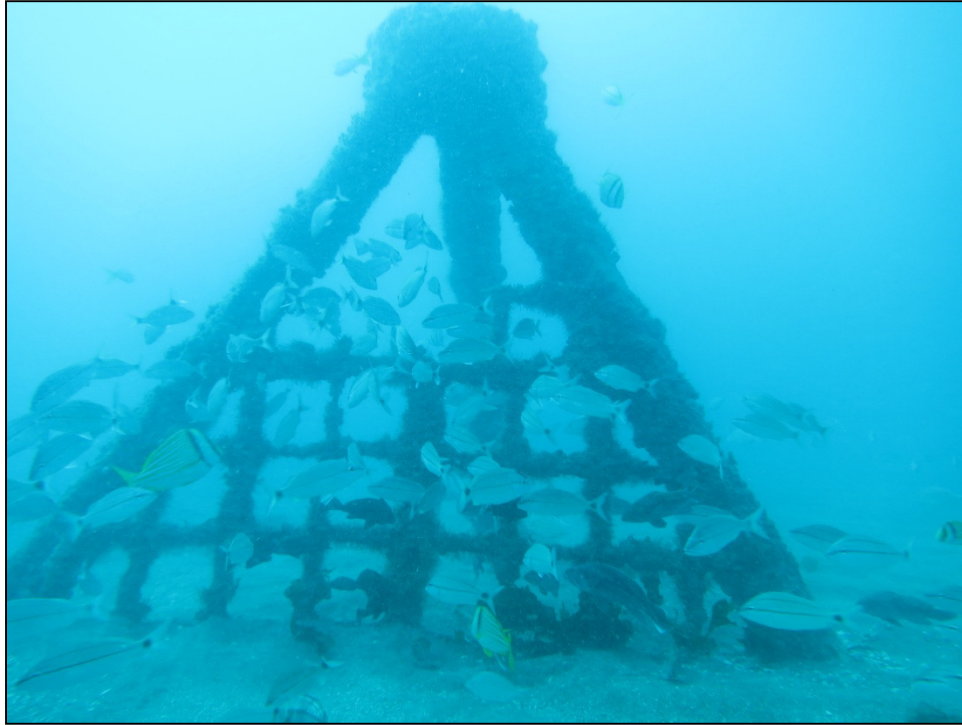
The Donaldson Triangle – Reefmaker’s Florida Special module is over 10' tall with a 12' triangular base and originally had steel panels (designed much like lattice work) fitted to the sides. The module has approximately 800 square feet of surface area and a weight in air of over 5,000 lbs. The concrete structural component of the Reefmaker Florida Special module was still intact with no noticeable damage (Photograph 1). However, the steel components of the module were heavily corroded and the steel lattice work has become separated on two sides of the module and now lays partially buried in the sand beside the module (Photograph 2). There was also some noticeable settling of the structure into the sandy bottom observed during the survey, as shown in Figure 3.

**Photograph 1.** A frontal view of the Donaldson Triangle - Reefmaker Florida Special.

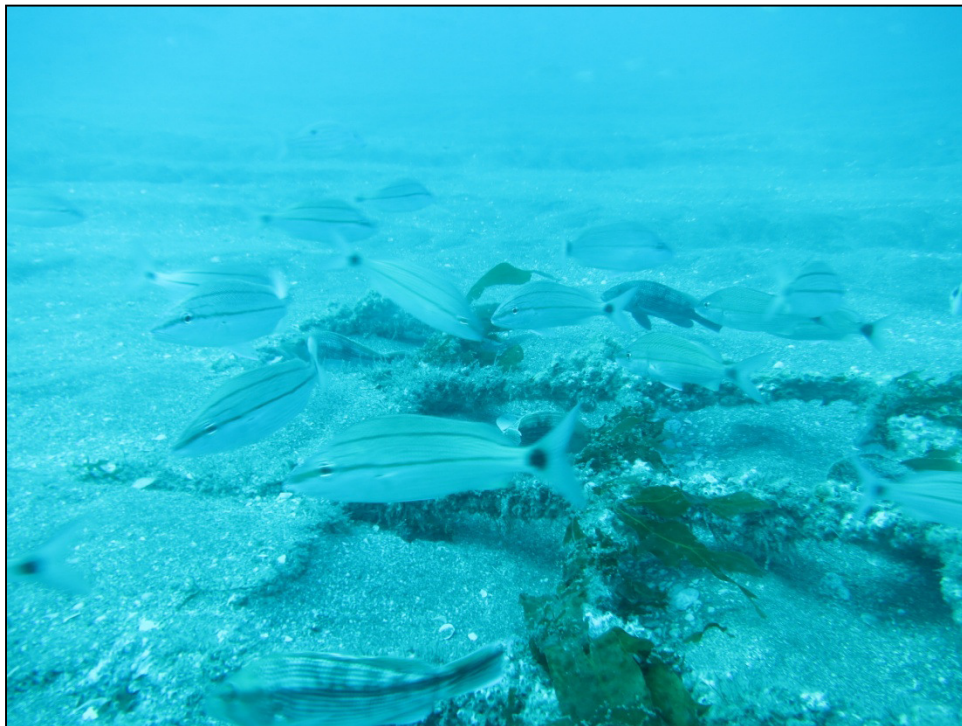
**Photograph 2.** A view of one of the two sides of the Reefmaker Florida Special that have separated from the structure.

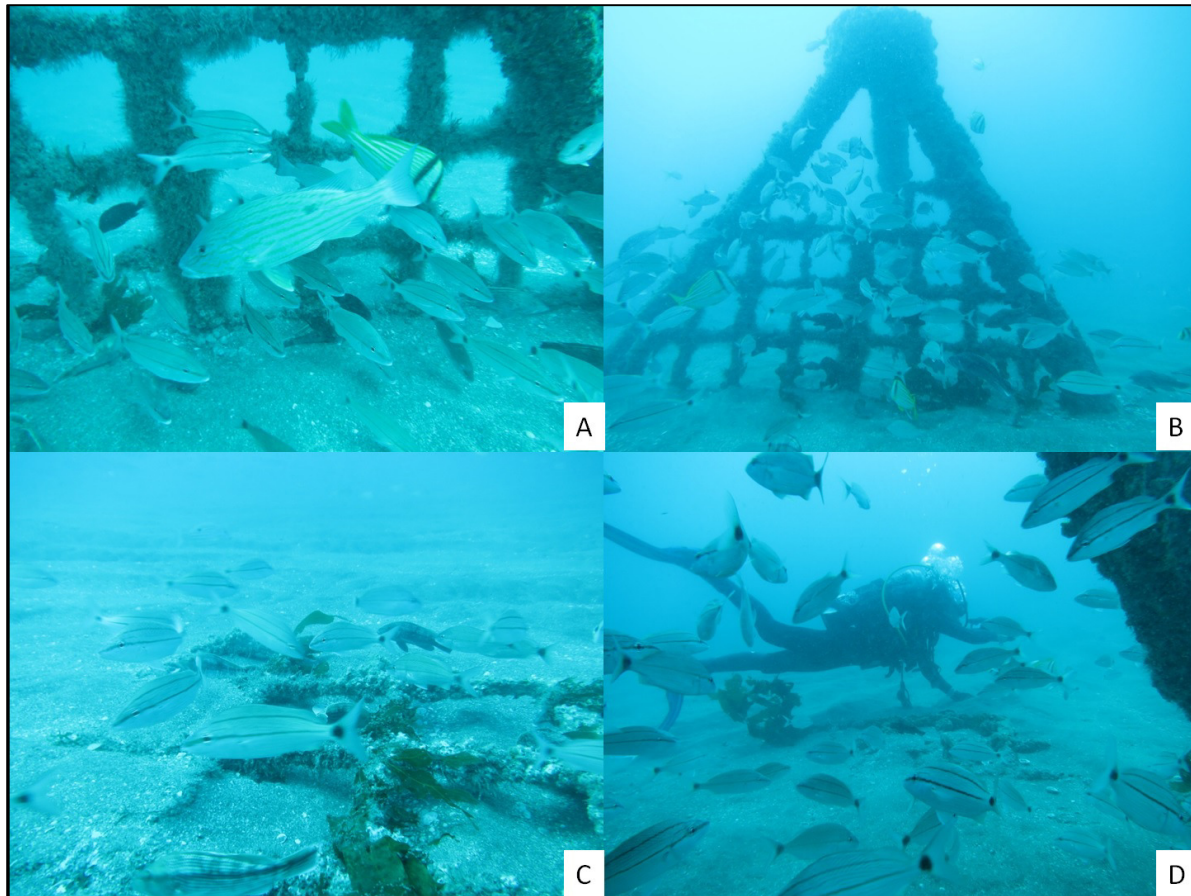
**Figure 3.** An overview of the Donaldson Triangle Reefmaker Florida Special artificial reef looking north (A), south at the Reefmaker Florida Special, (B), east (C), and west (D).

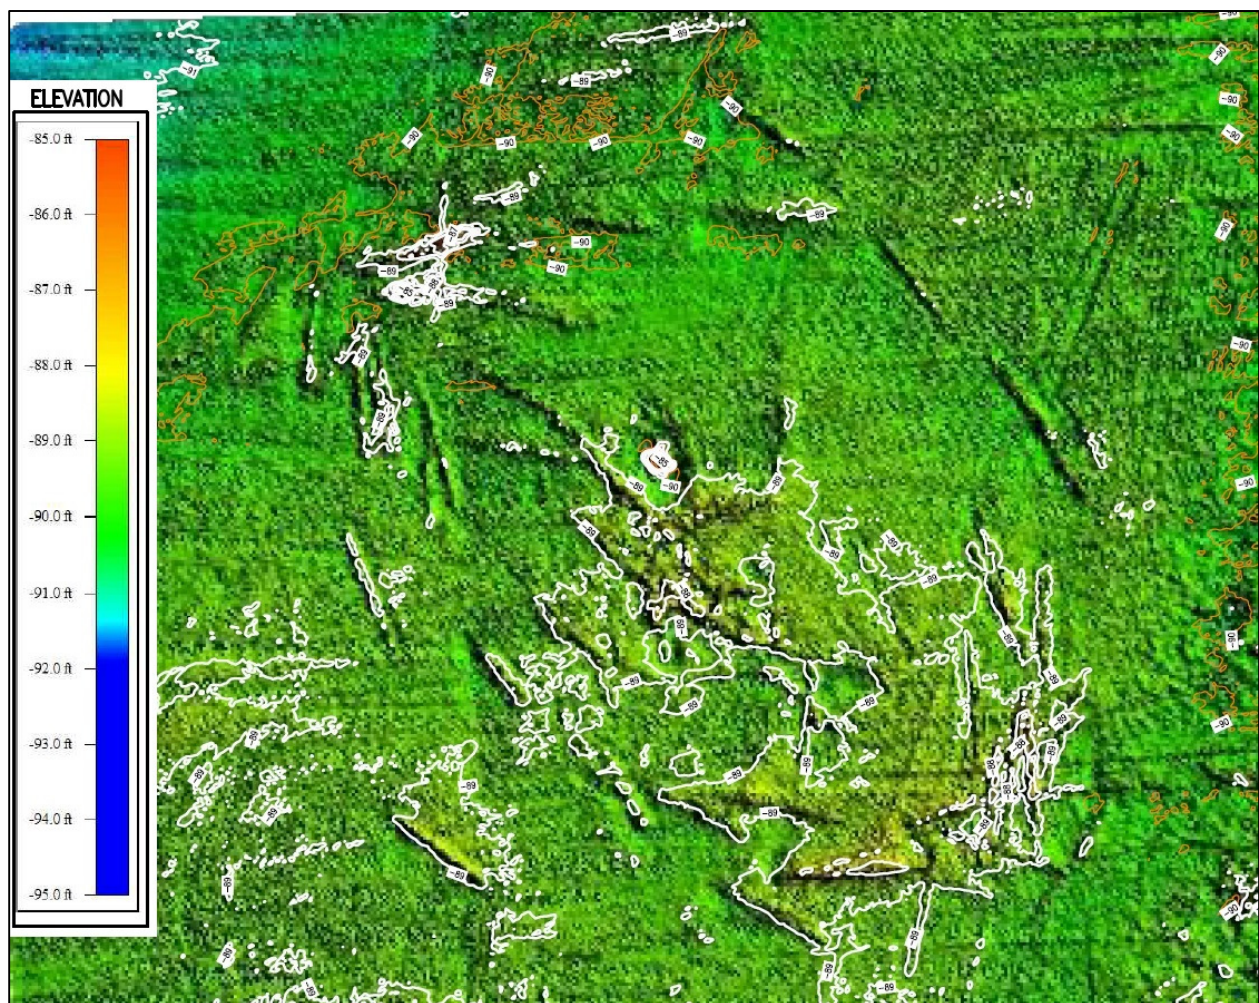
The multi-beam survey of the Reef was completed on June 28<sup>th</sup>, 2017. The Reef material is scattered throughout the bottom and is approximately 250 feet in diameter. Water depths within the Reef area ranged from 85 to 90 feet deep at the time of the survey, with the shallowest water occurring in approximately the center of the Reef, where a large (approximately 8 feet diameter) culvert is located (Figure 2).

**Figure 2.** An overview of the Sirotkin Site 2 depths and layout of concrete material.

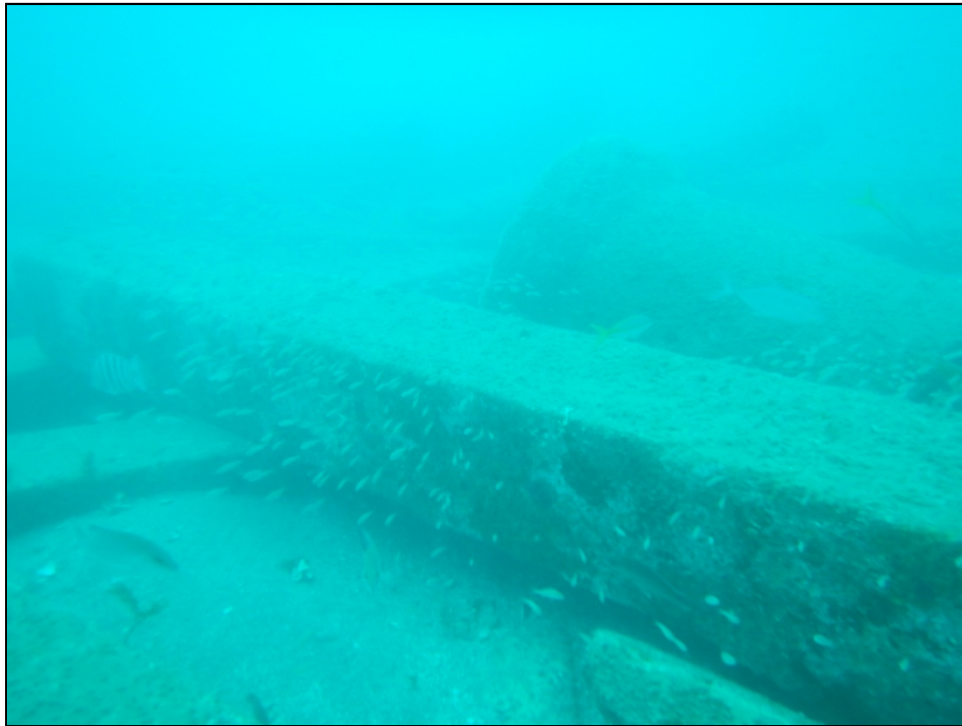
The concrete components of the culverts and poles were intact, and very few of the steel rebar and reinforcing components were exposed or corroded (Photograph 1). It was not apparent if the reduced amount of damage to the concrete structures was due to the condition before placement, reduced to impacts to the structures due to the increased water depths, or reduced wave action after placement. Approximately 6 inches of primarily coarse sand was noted around the bases of the concrete poles, but no settlement/sinking of the Reef as a whole was apparent during the survey (Figure 3).

**Photograph 1.** No obvious damaged, exposed, or corroded rebar was observed on the concrete culverts and poles at South County Site 2.

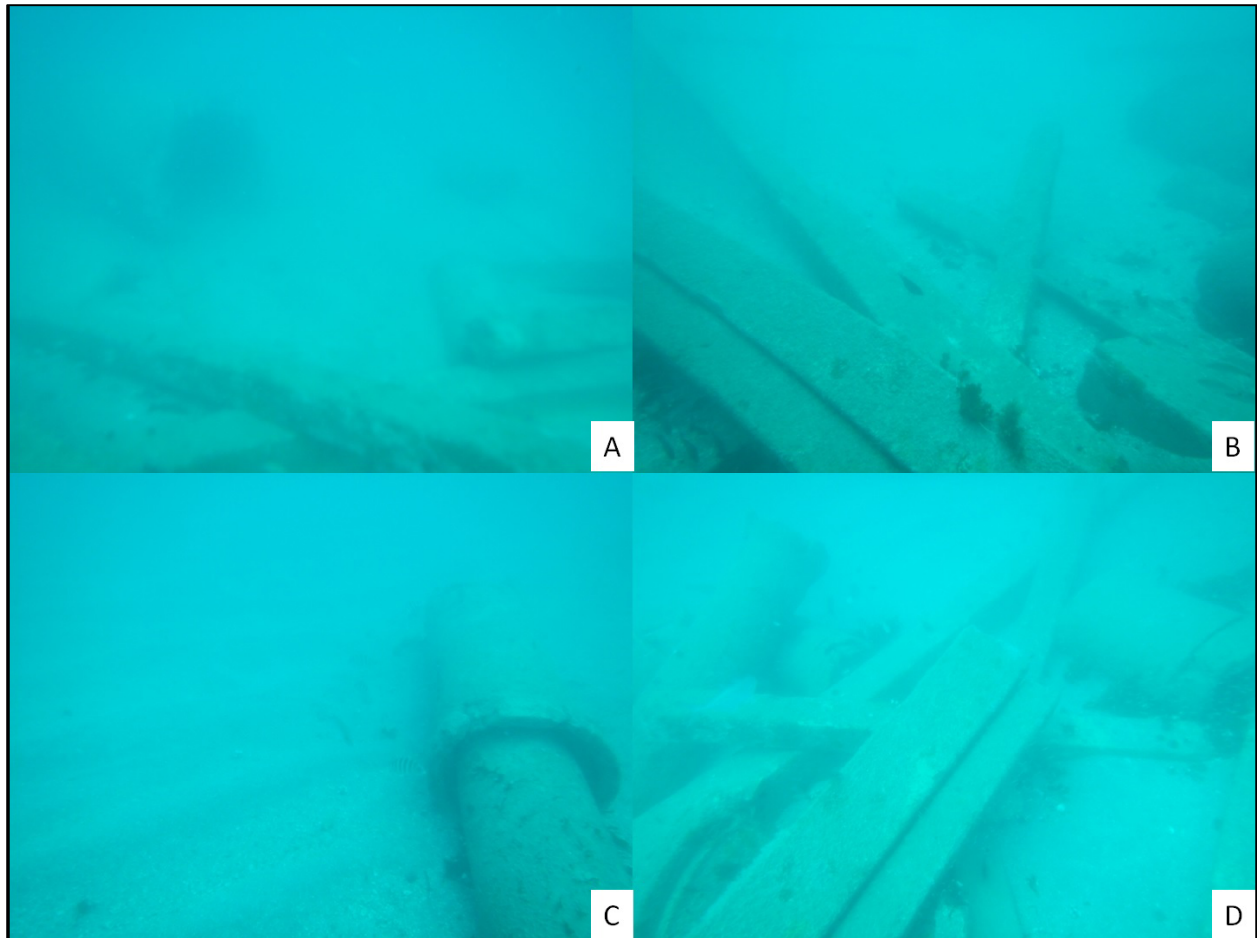
**Figure 3.** An overview of Sirotkin artificial reef Site 2 looking north (A), south, (B), east (C), and west (D) from the tallest point on the reef.

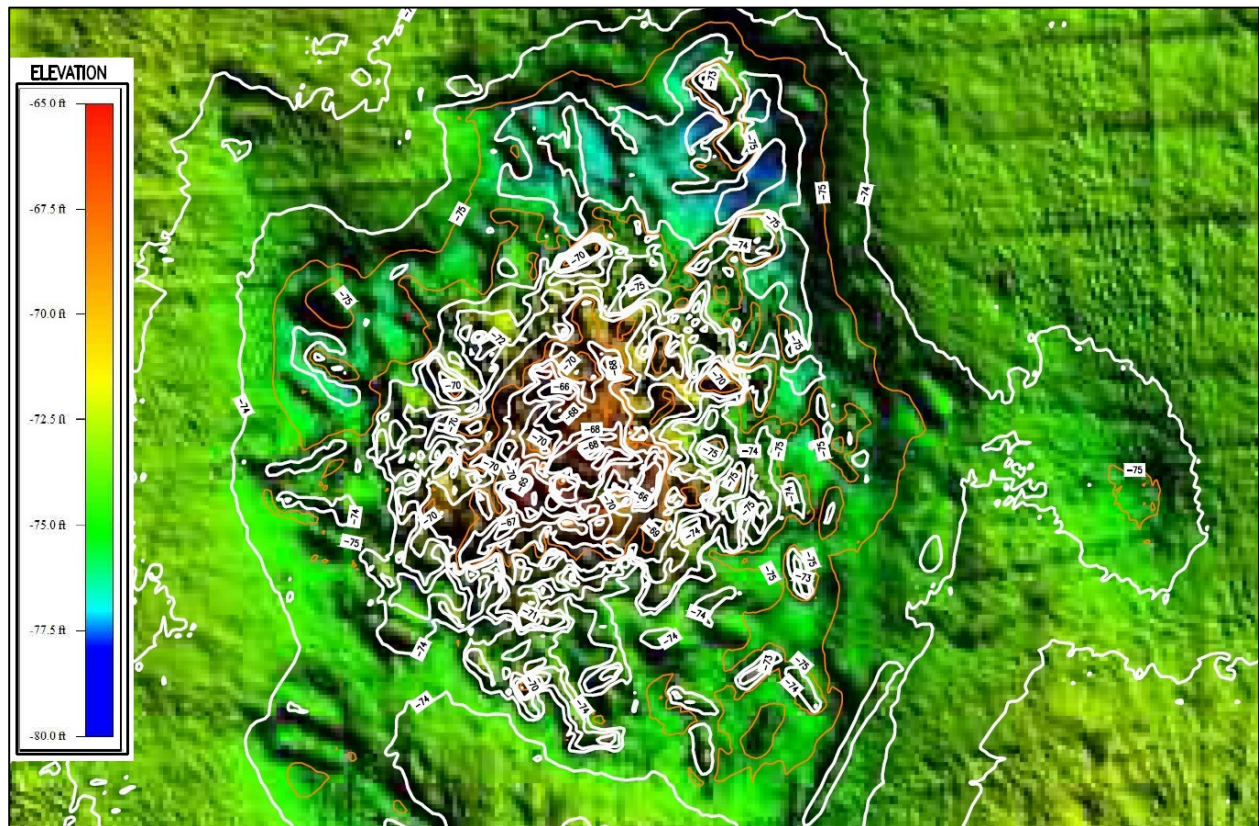
The multi-beam survey of the Reef was completed on June 27<sup>th</sup>, 2017. The South County Reef Site 14 is approximately 90 feet in diameter. Water depths within the Reef area ranged from 65 to 77 feet deep at the time of the survey, with the shallowest water occurring just southwest of the approximate center of the Reef (Figure 2).

**Figure 2.** An overview of the South County Reef Site 14 depths and layout of concrete material.

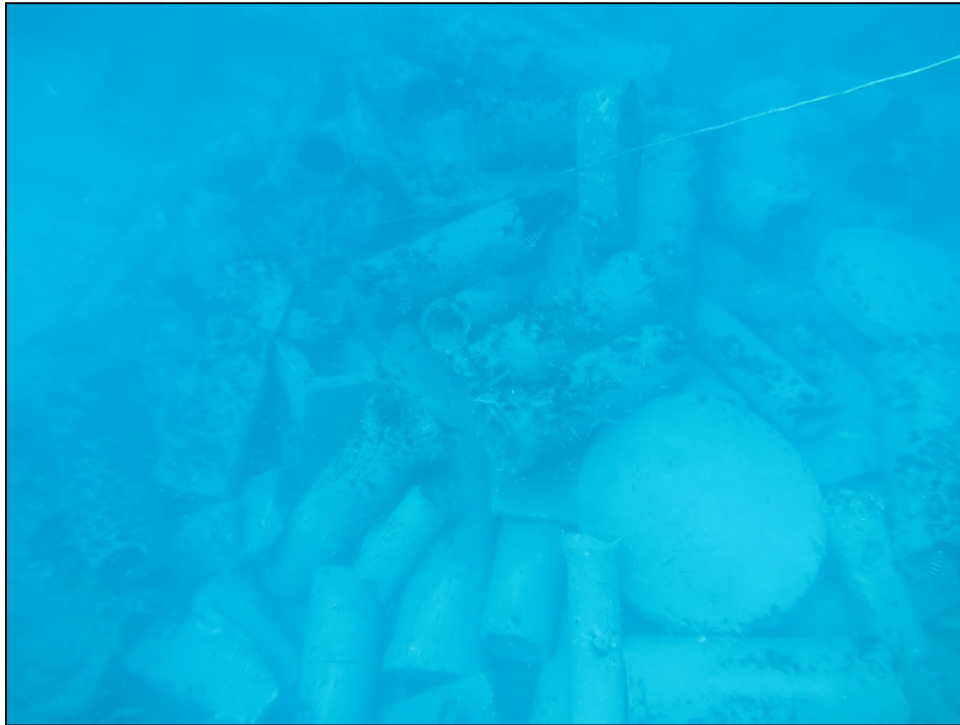
The concrete components of the culverts and poles were intact (Photograph 1); however, the steel rebar and reinforcing components were exposed and corroded on many of the structures, especially at the ends of the culverts (Photograph 2). It was not apparent if the damage was there before placement, due to impacts sustained during placement, or the result of the combination of wave action, erosion, and corrosion after placement. Additionally, approximately 2 feet of primarily coarse sand was seen built up around the bases of the concrete culverts and poles, and the Reef appears to lie in a shallow sandy depression, so some scouring seems to have occurred (Figure 3).

**Photograph 1.** An aerial view of the concrete culverts, poles, and slabs on the Reef.

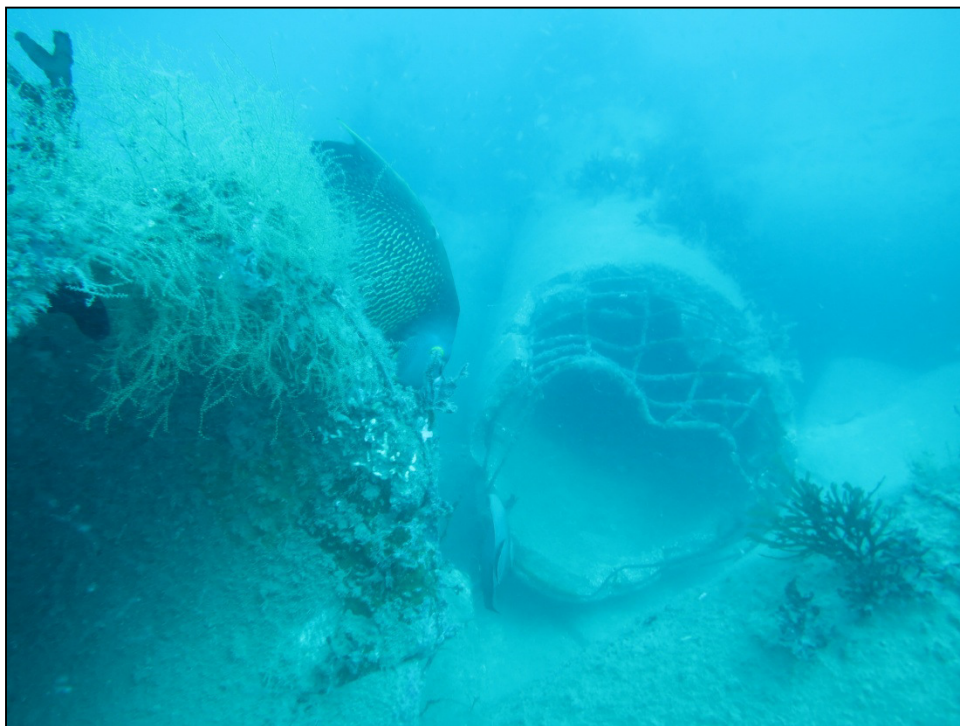
**Photograph 2.** Damage and exposed, corroded, rebar typical of many of the ends of the concrete culverts on poles on the Reef.

The concrete components of the culverts and poles were intact; however, the steel rebar and reinforcing components were exposed and corroded on many of the structures, especially at the ends of the culverts. Approximately 2 feet of coarse sand was seen built up around the bases of the concrete culverts and poles, and the Reef now appears to lie in a shallow sandy depression, indicating some scouring seems to have occurred.

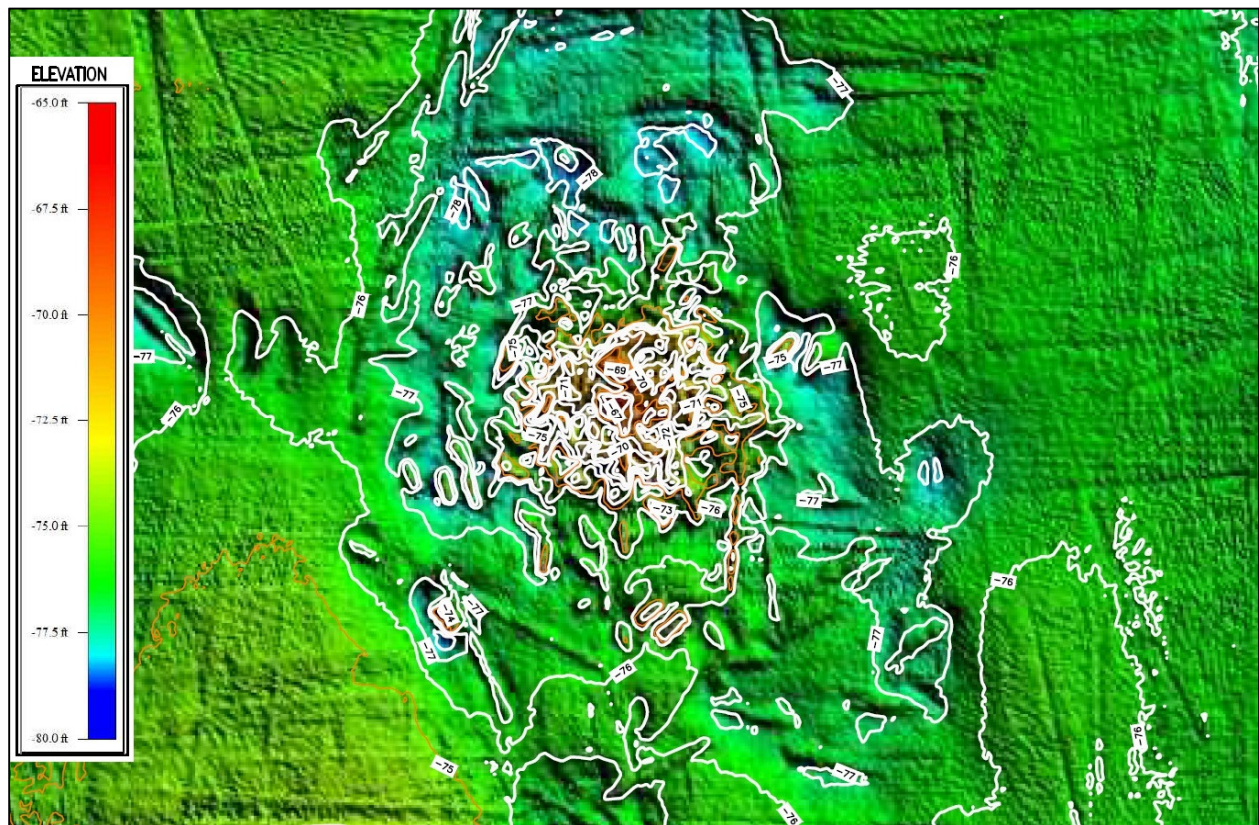
The multi-beam survey of the Reef was completed on June 27<sup>th</sup>, 2017. The Reef is approximately 70 feet in diameter. Water depths within the Reef area ranged from 67 to 77 feet deep at the time of the survey, with the shallowest water occurring just west of the center of the Reef (Figure 2).

**Figure 2.** An overview of the South County Site 15 depths and layout of concrete material.

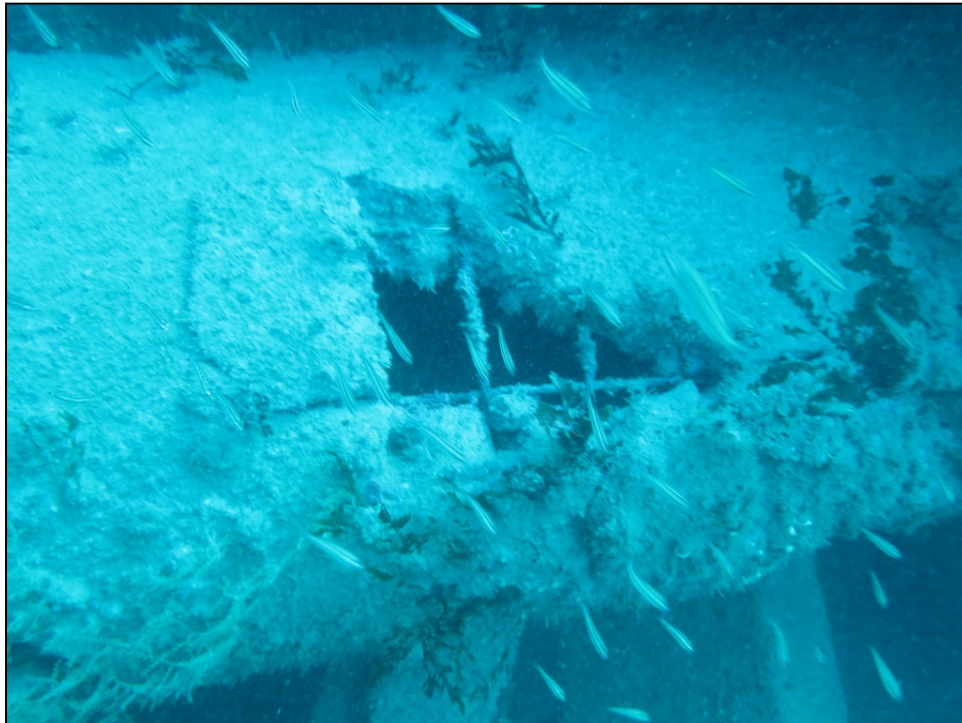
The concrete components of the culverts and poles were intact; however, the steel rebar and reinforcing components were exposed and corroded on many of the structures (Photograph 1). It was not apparent if the damage was there before placement, due to impacts sustained during placement, or the result of wave action, erosion and corrosion after placement. Approximately 2 feet of primarily coarse sand was noted around the bases of the concrete culverts and poles, but no settlement/sinking of the Reef as a whole was apparent during the survey (Figure 3).

**Photograph 1.** Damaged, exposed and corroded rebar typical of many of the concrete culverts and poles at South County Site 15.

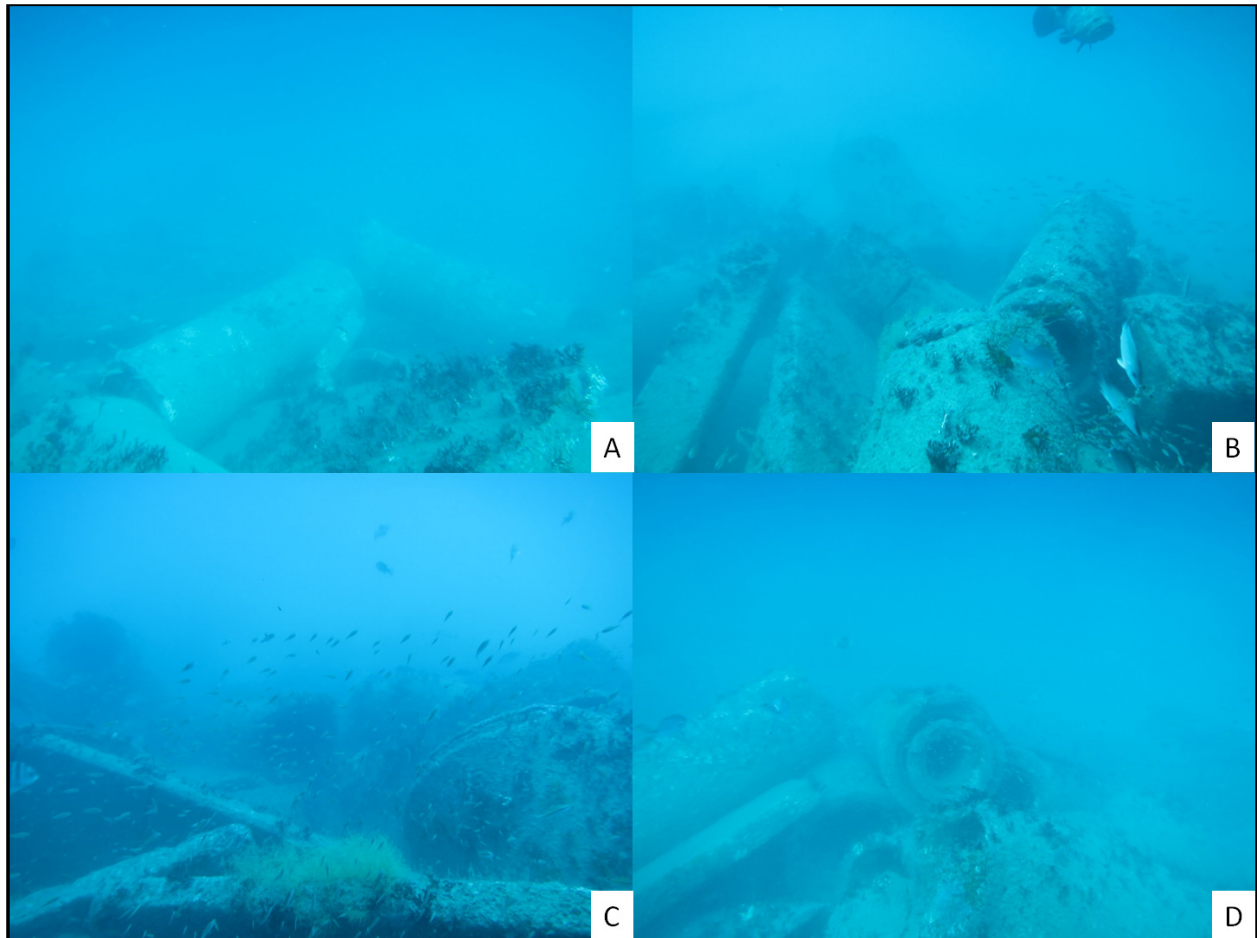
**Figure 3.** An overview of South County artificial reef Site 15 looking north (A), south, (B), east (C), and west (D) from the tallest point on the reef.
