FIELD OBSERVATION REPORT

RE: **SECOND ANNUAL FIELD OBSERVATION REPORT FOR THE MARINE
RESOURCE AND STRUCTURAL SURVEY OF THE SIROTKIN ARTIFICIAL REEF
SITE 2 IN MARTIN COUNTY, FLORIDA**

MARTIN COUNTY ARTIFICIAL REEF MONITORING 2017 - 2018

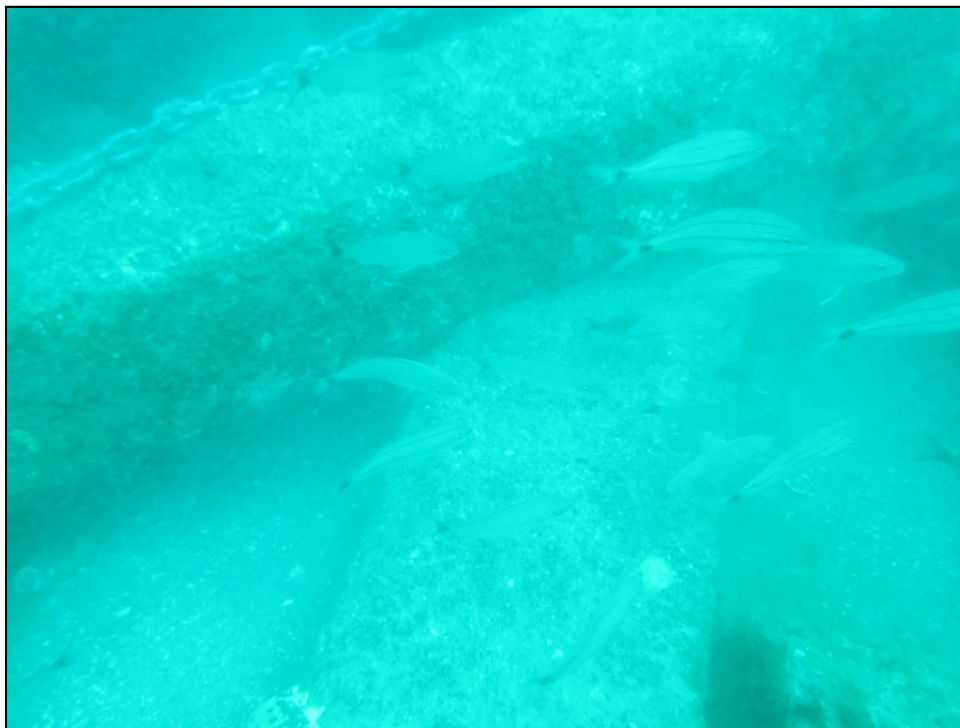
The concrete components of the culverts and poles were intact, and very few of the steel rebar and reinforcing components were exposed or corroded (Photograph 1). It was not apparent if the small amount of damage to the concrete structures was due to the condition before placement, impacts to the structures during placement, or increased corrosion after placement; however, the 2018 monitoring survey structural observations were similar to that of the 2017 monitoring survey. Approximately 6 inches of primarily coarse sand was noted around the bases of the concrete poles, but no settlement/sinking of the Reef as a whole was apparent during the survey (Figure 2).

Photograph 1. No obvious damaged, exposed, or corroded rebar was observed on the concrete culverts and poles at the Sirotkin Artificial Reef Site 2.

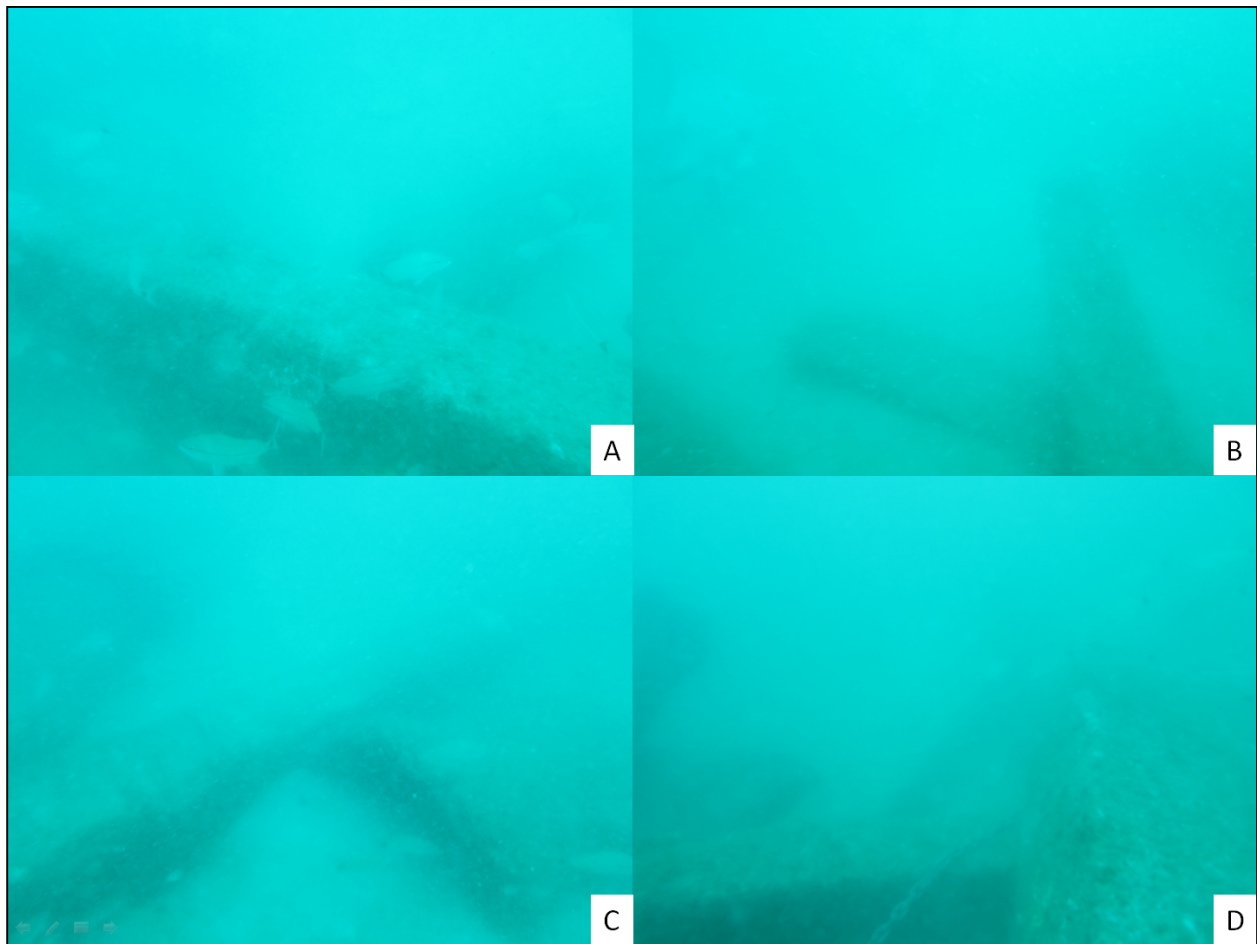
Figure 2. An overview of Sirotkin Artificial Reef Site 2 looking north (A), south, (B), east (C), and west (D) from above the tallest point on the Reef.

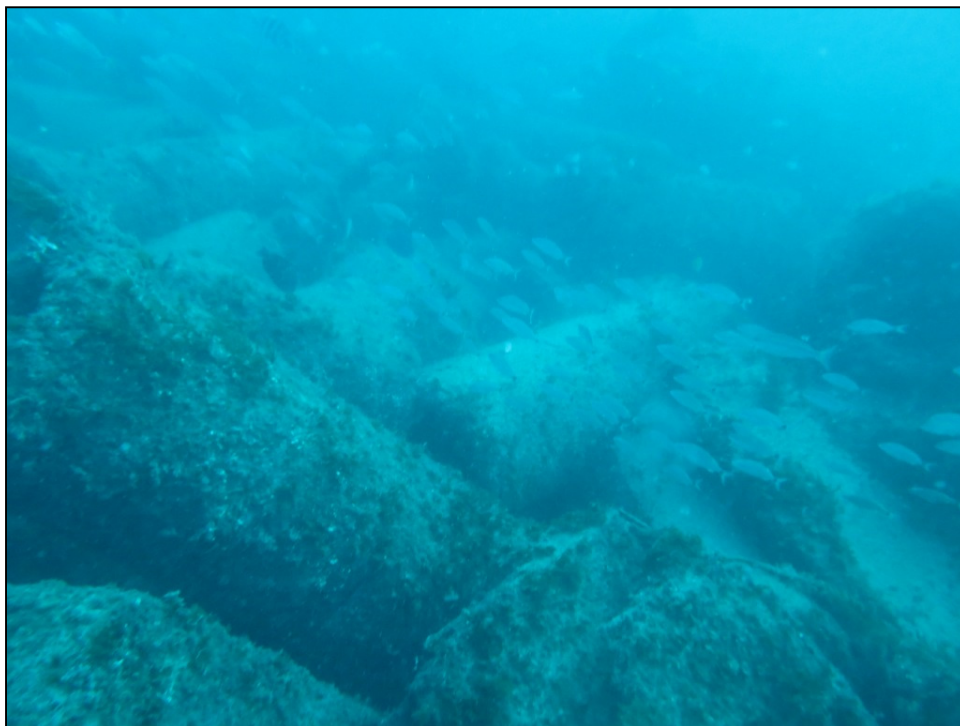
The concrete components of the culverts, poles, and slabs were intact (Photograph 1); however, the steel rebar and reinforcing components were exposed and corroded on many of the structures, especially at the ends of the culverts (Photograph 2). It was not apparent if the damage was due to the condition before placement, due to impacts sustained during placement, or the result of the combination of wave action, erosion, and corrosion after placement. Additionally, approximately two feet of primarily coarse sand was seen built up around the bases of the concrete culverts, poles, and slabs, and the Reef appears to lie in a shallow sandy depression, so some scouring seems to have occurred; however, the 2018 monitoring survey structural observations were similar to that of the 2017 monitoring survey.

Photograph 1. A view of the concrete culverts, poles, and slabs on the Reef.

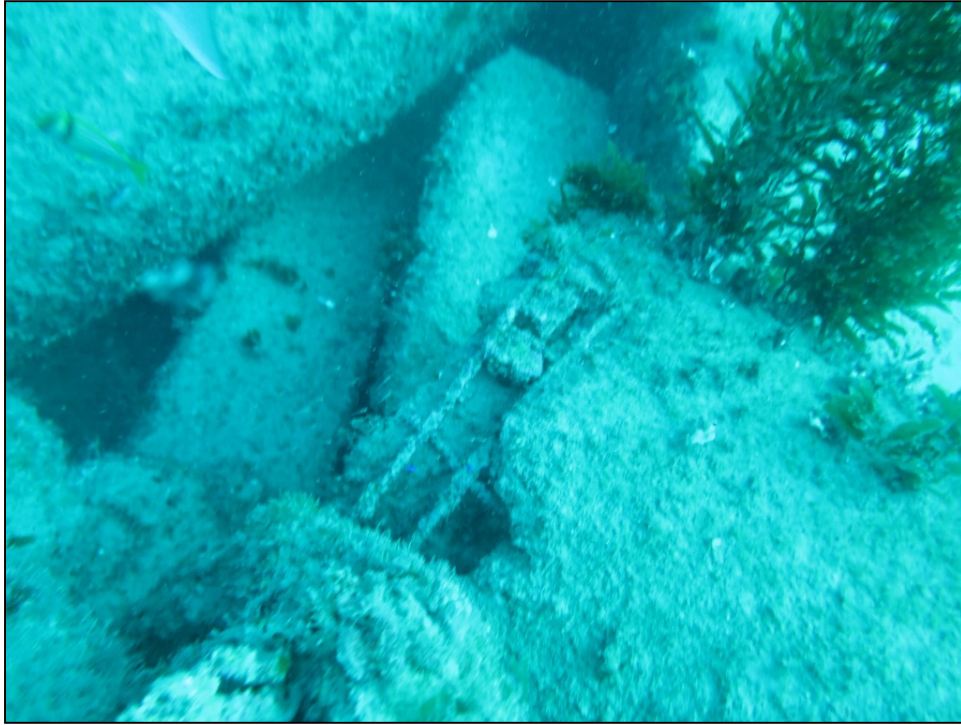
Photograph 2. Damaged, corroded, and exposed rebar typical of many of the ends of the concrete culverts and poles on the South County Artificial Reef Site 14 showing growth.

The concrete components of the culverts and poles were intact; however, the steel rebar and reinforcing components were exposed and corroded on many of the structures, especially at the ends of the culverts. Approximately two feet of coarse sand was seen built up around the bases of the concrete culverts and poles, and the Reef appears to lie in a shallow sandy depression, indicating some scouring seems to have occurred. This is consistent with the condition of the Reef during the 2017 monitoring survey.

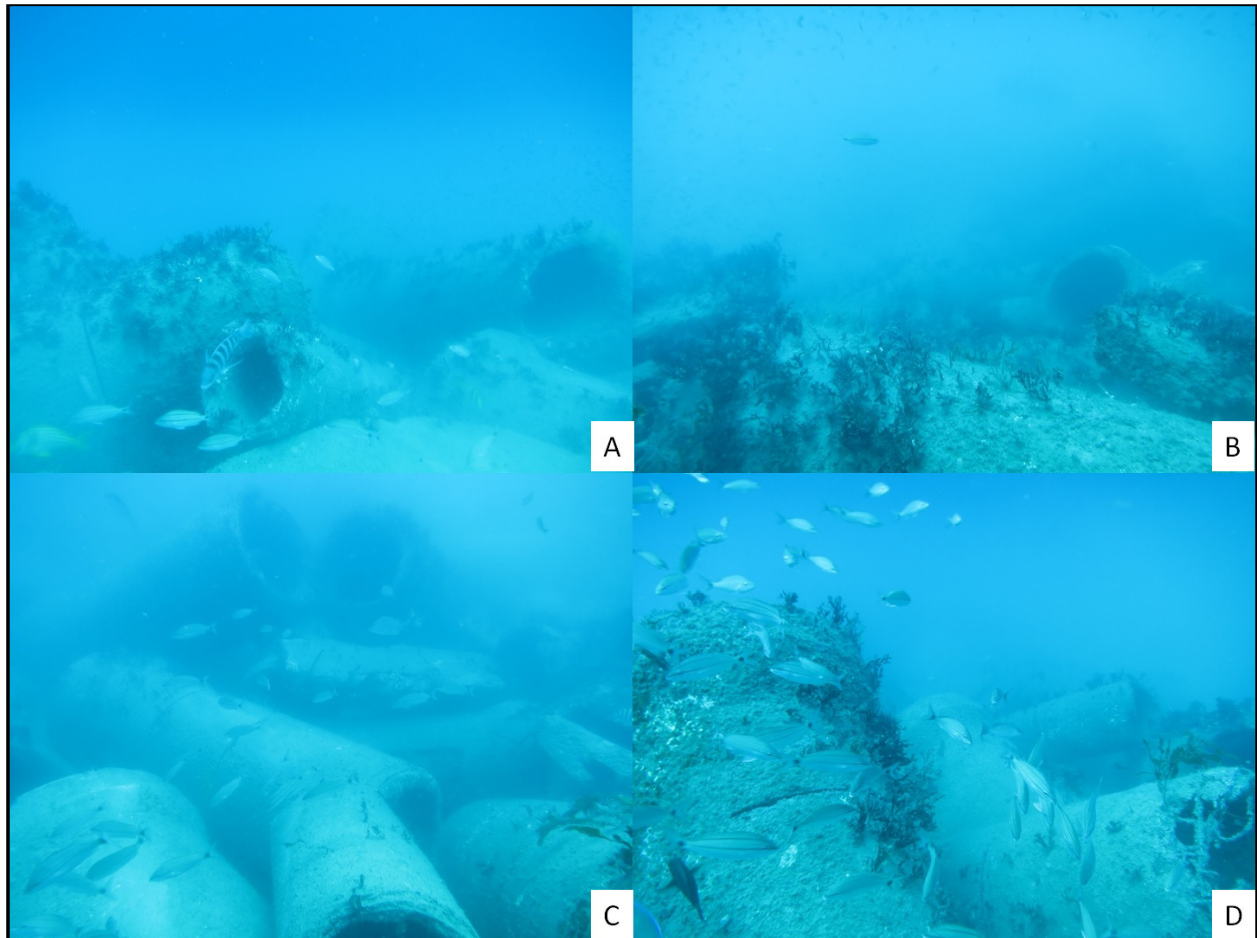
Figure 2. An overview of the South County Artificial Reef Site 14 looking north (A), south, (B), east (C), and west (D) from the tallest point on the Reef.

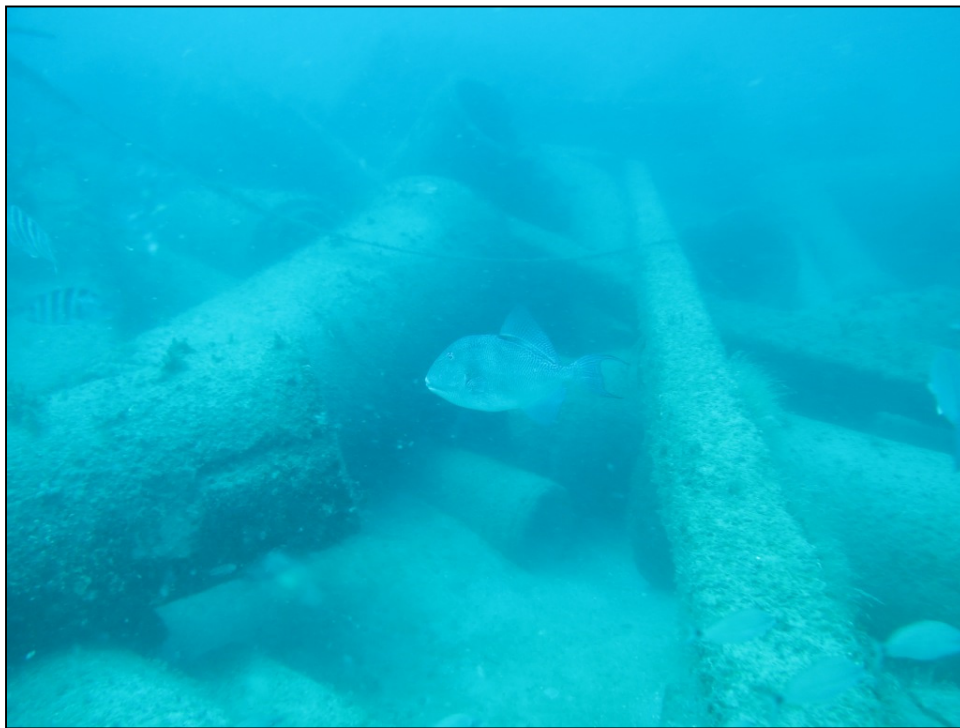
The concrete components of the culverts and poles were intact, and very few of the steel rebar and reinforcing components were exposed or corroded (Photograph 1). It was not apparent if the small amount of damage to the concrete structures was due to the condition before placement, impacts to the structures during placement, or increased corrosion after placement; however, the 2018 monitoring survey structural observations were similar to those of the 2017 monitoring survey. Approximately 6 inches of primarily coarse sand was noted around the bases of the concrete poles, but no settlement/sinking of the Reef as a whole was apparent during the survey.

Photograph 1. No obvious damaged, exposed, or corroded rebar was observed on the concrete culverts and poles at South County Artificial Reef Site 15.

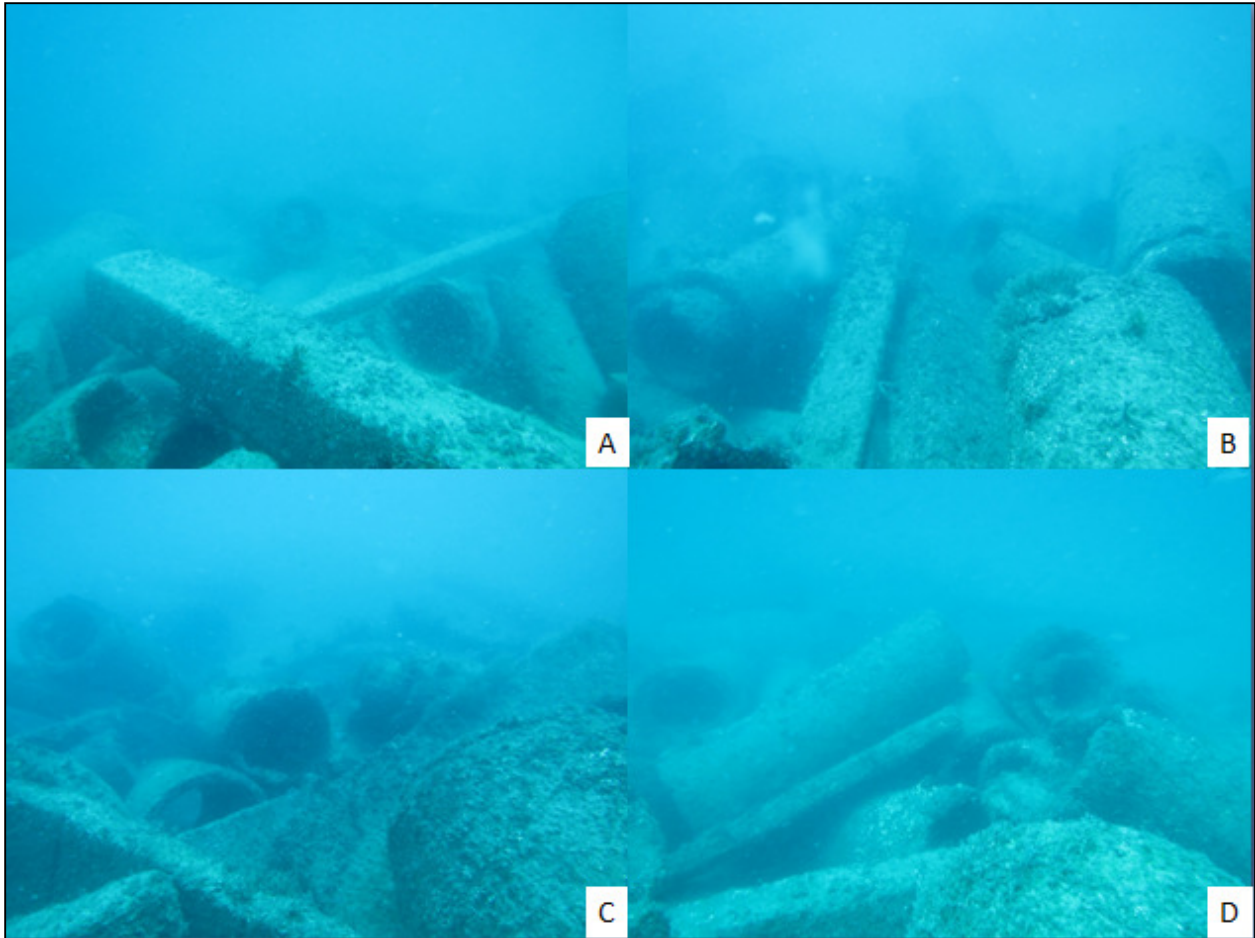
Figure 2. An overview of the South County Artificial Reef Site 2 looking north (A), south, (B), east (C), and west (D) from above the tallest point on the Reef.
