# Repetitive Loss Area Analysis

**Martin County, Florida**  
**CRS Community**  
**120161**

**September 29, 2026**

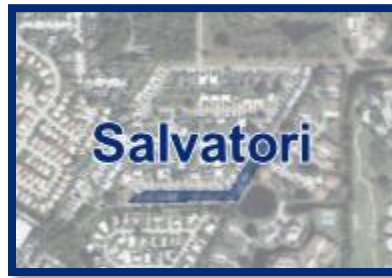
#### Salvatori

An aerial image of Upon further review, it was determined that flooding in this Repetitive Loss Area occurred prior to 2008. However, in late 2011, Martin County completed modifications to its Manatee Creek – Phases 2 & 3 Stormwater Quality Retrofit project, which replaced two existing 60-inch corrugated metal culverts with a 10-foot by 6-foot concrete box culvert downstream of Salvatori. The supportive modeling efforts indicate that the storm stages in Salvatori were lowered by more than two feet. The County will consider this area mitigated and submit the appropriate Repetitive Loss Update Forms to the NFIP Customer Service Center.

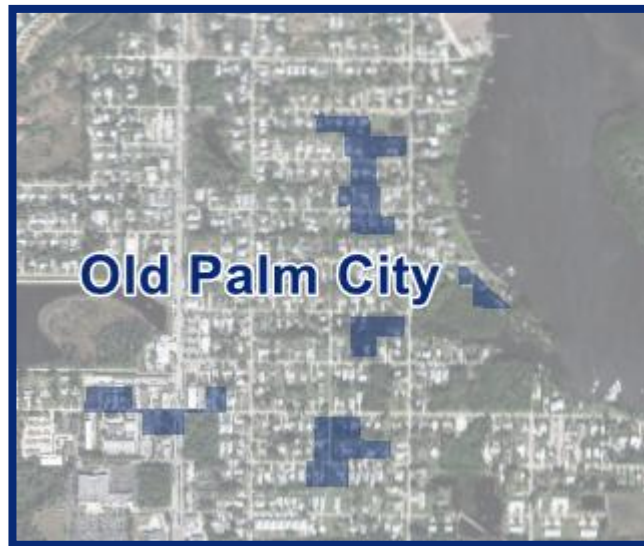
#### Old Palm City

The County has initiated an Integrated Watershed Management Plan (IWMP) that includes the Old Palm City Repetitive Loss Area, which employs a range of strategies. Funds have been secured for design and engineering work but not implementation. This site is a complex network of roadways with coastal water intrusion from multiple points. Decisions will have to be made, coordinated between the county and property owners, on whether this will involve the use of a county easement along the shoreline, providing comprehensive protection for the entire community, or if the primary defense from high tides will be at Cornell Road. In either case, whether solved by road raising or coastal berm creation, designs will need to be stitched into the urban fabric and harmonized with

private property. Community outreach will be necessary to discuss requirements for the project, such as potential elevation of private property and structures and future harmonization. Pumps may be required if the primary protection measure includes coastal berms. This would create perpetual operation and maintenance needs for equipment. The County may also pursue strategic property acquisition to increase stormwater volume capacity.
